April - June, 2013  
Storm Damage  
Images, Page 1 of 4

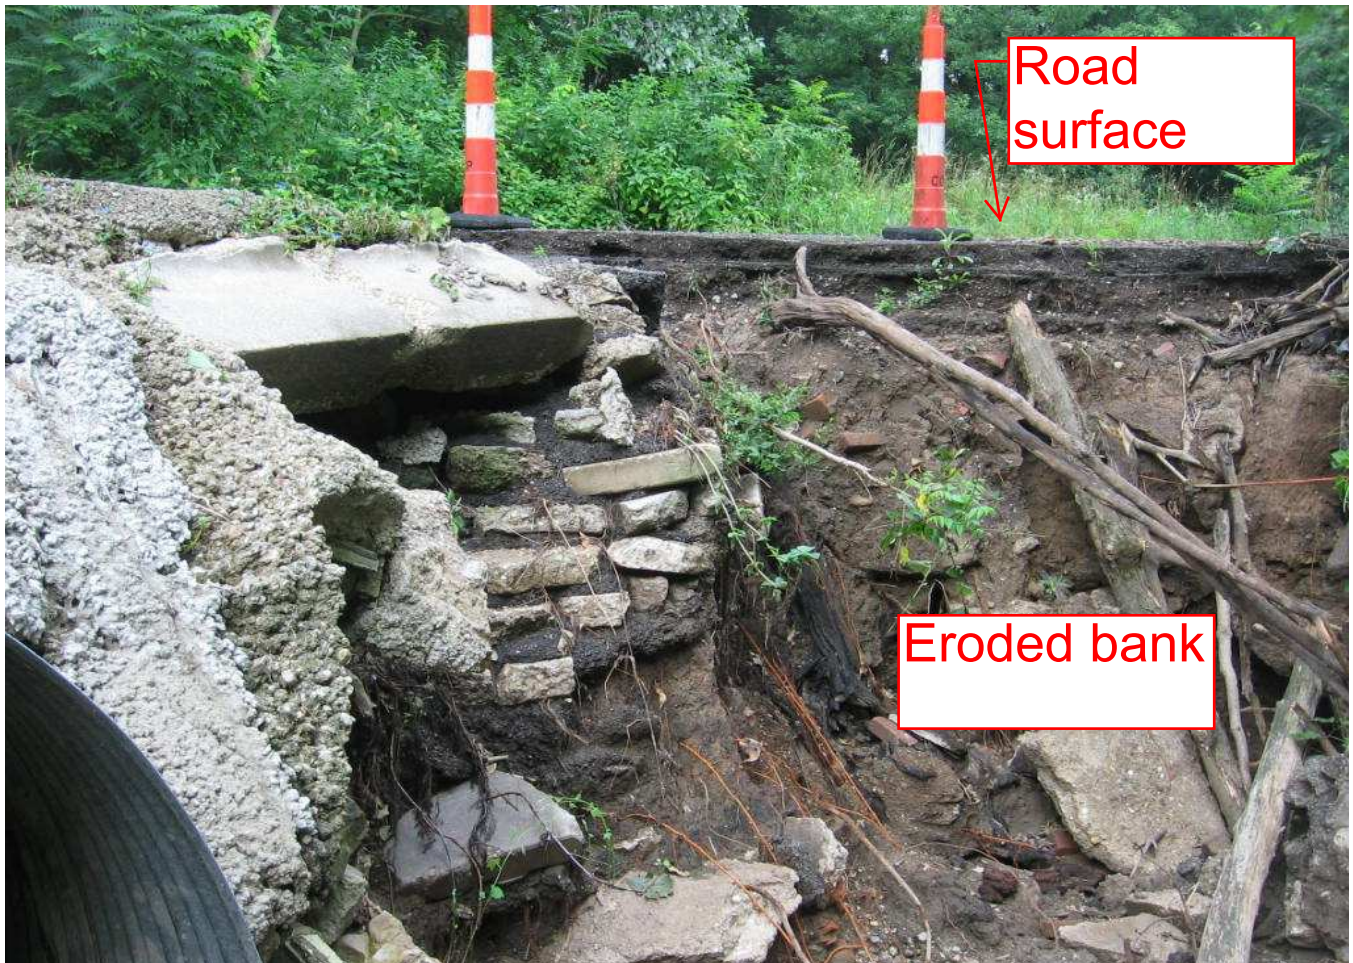
Road surface

Eroded bank

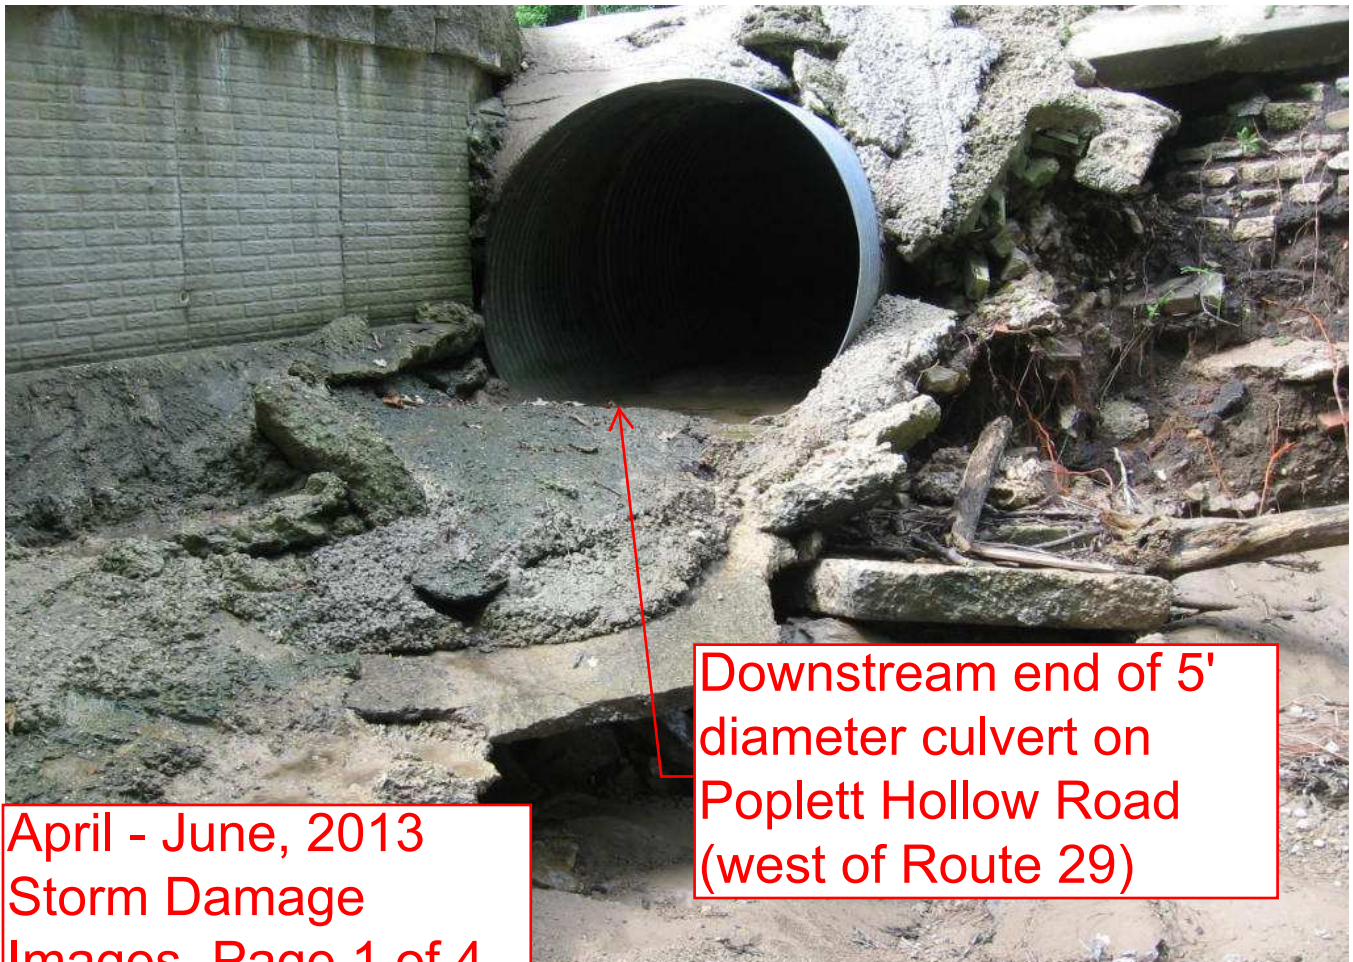
Downstream end of 5' diameter culvert on Poplett Hollow Road (west of Route 29)
