COST OVERRUN DETAIL – PARKWOOD COMMONS

February 2021

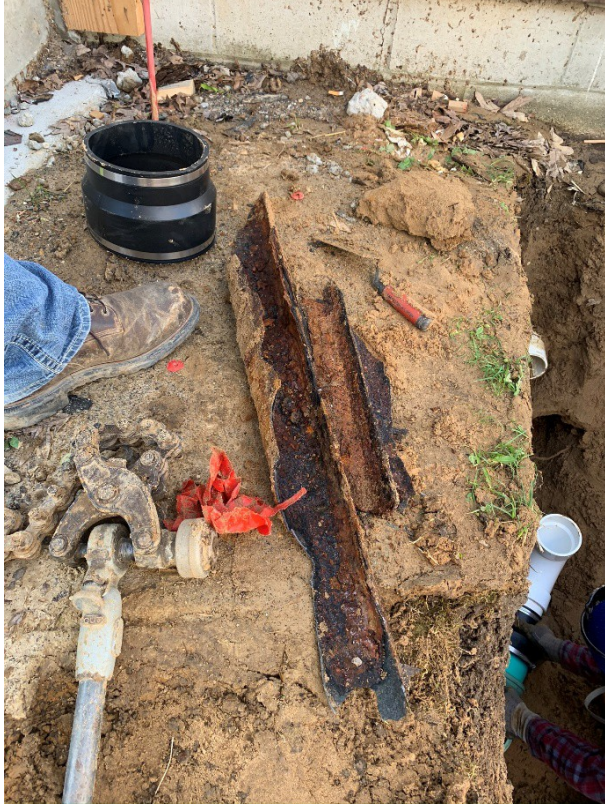
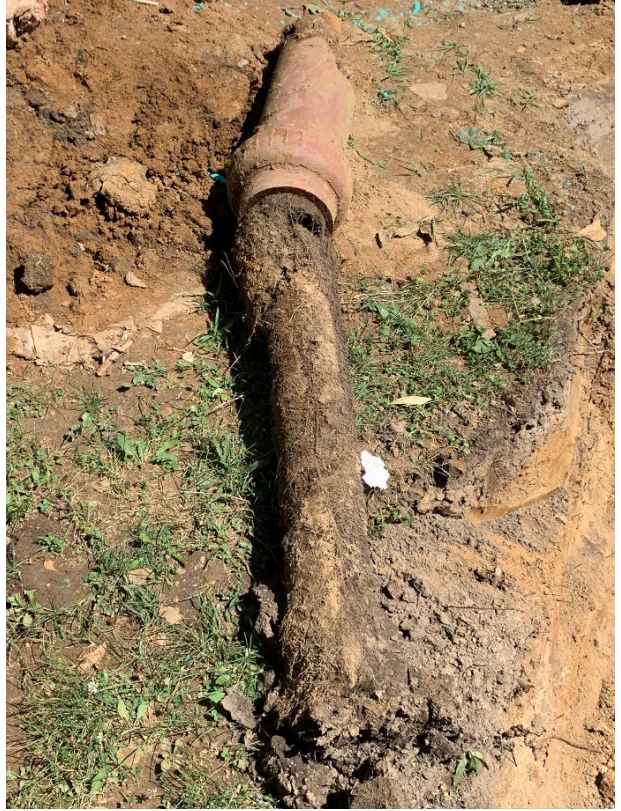
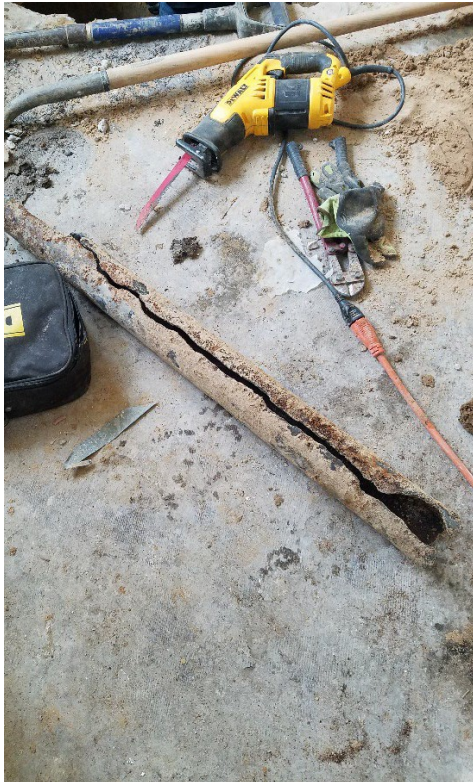
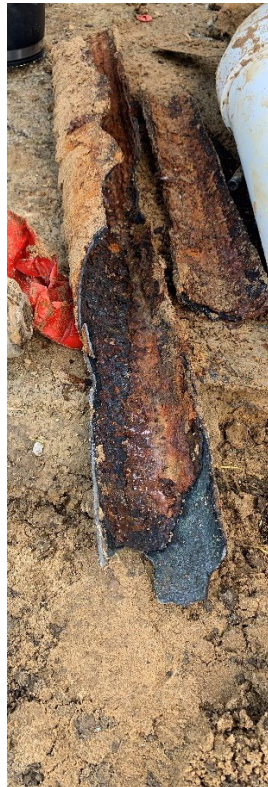
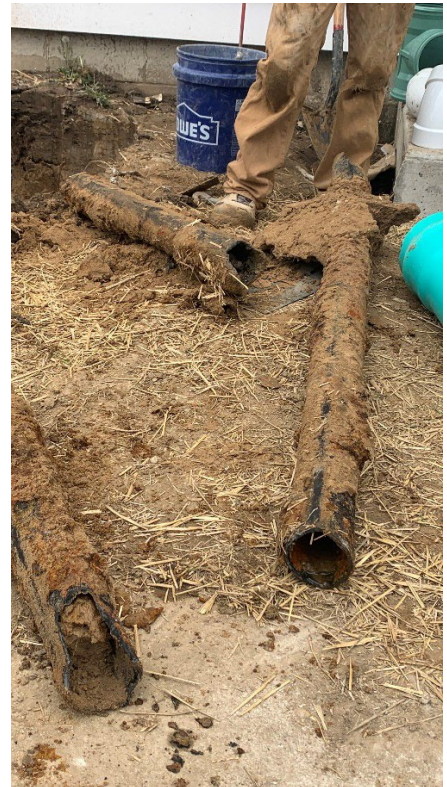
Exhibit A:
Previously Existing Cast Iron Sewer Lines

Sewer Lines: The extensive repairs and overall condition of the existing cast iron sewer lines were unknown beyond minor repairs prior to closing. The original scope included the lines to be cambered and jetted with contingency for repairs as needed. After construction start, during an attempt to connect new piping to the existing line, it was made clear that there was an issue with the existing lines. Upon further inspection using cameras, it became clear that the existing underground sewer lines for all 100 units would need to be replaced.

Replacements occurred under the slab inside each unit and were extended using scheduled 40 PVC line to tie into the exterior sewer main. The PVC replacement includes a 4" diameter as opposed to the narrower 3" diameter cast iron piping as well. Scheduled 40 PVC has significant advantages for the present and long-term wellbeing of the residents. On the contrary, the former cast iron sewer lines were significantly deteriorated as shown in pictures provided below in Exhibit A. The deterioration of the cast iron piping would lead to costly ongoing maintenance expenses and constant tenant interruption. Health issues due to backed up sewage, excess moisture resulting in mold due to leaks, and unflattering smells were becoming apparent and would only increase without the immediate replacement of the sewer lines using modern Scheduled 40 PVC piping.

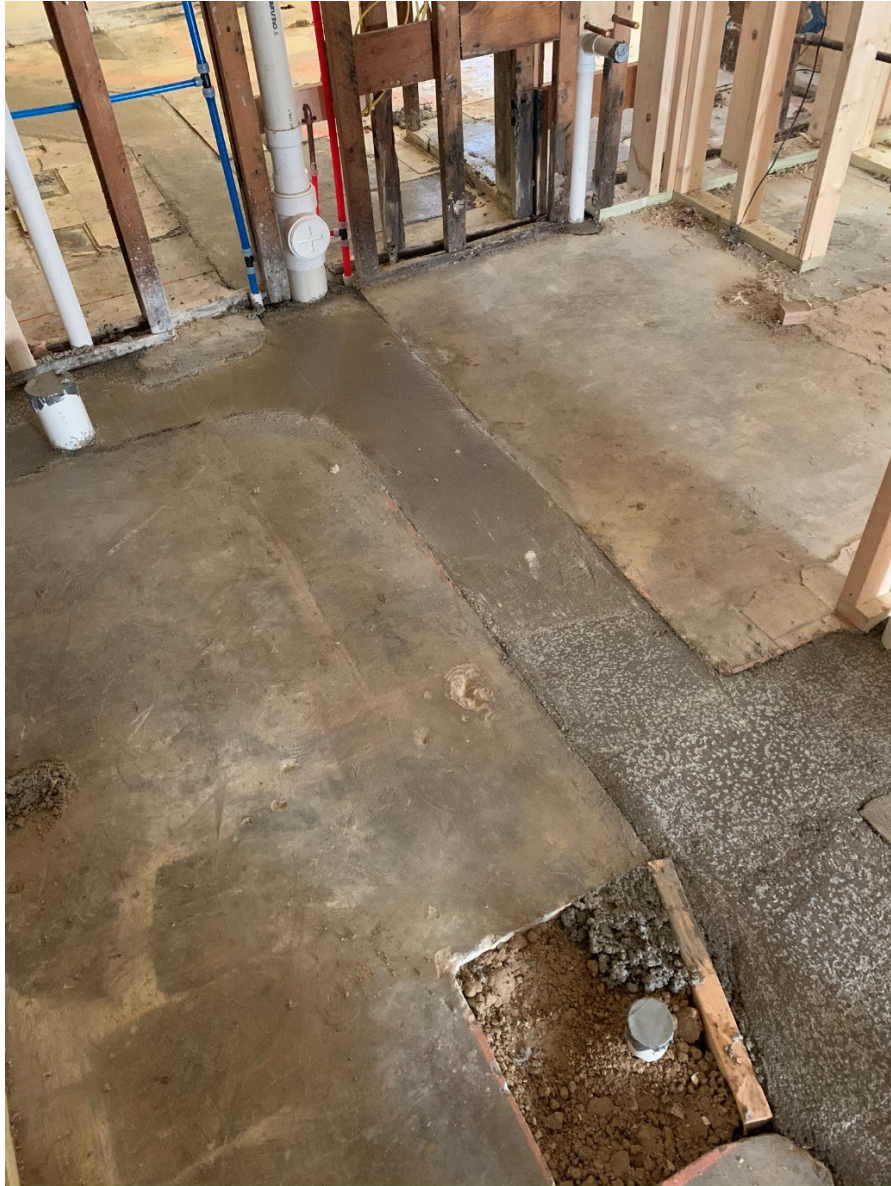
Exhibit B:
New Plumbing and Sewer Lines

Plumbing Lines: Copper water lines are common for older developments. While in some cases these lines are still intact and efficient pipes, the copper piping at Parkwood Commons was type m (the thinnest water type manufactured). During demolition, it was discovered that over the last 50 years the copper piping was deteriorated and had slowly leaked water into the interior walls. This leakage has resulted in mold, as further described below. To avoid additional leakage and continuous plumbing repairs, all interior copper water lines were replaced with Uponor water piping. The new Uponor water piping fully replaced the pre-existing copper pipe connecting to the main shut off in each unit. Uponor piping is a solution that, "minimizes connections, resists corrosion, pitting and scaling, offers greater resilience in freezing conditions and lasts the life of the structure." The newly fitted Uponor water lines can be viewed in Exhibit B below.

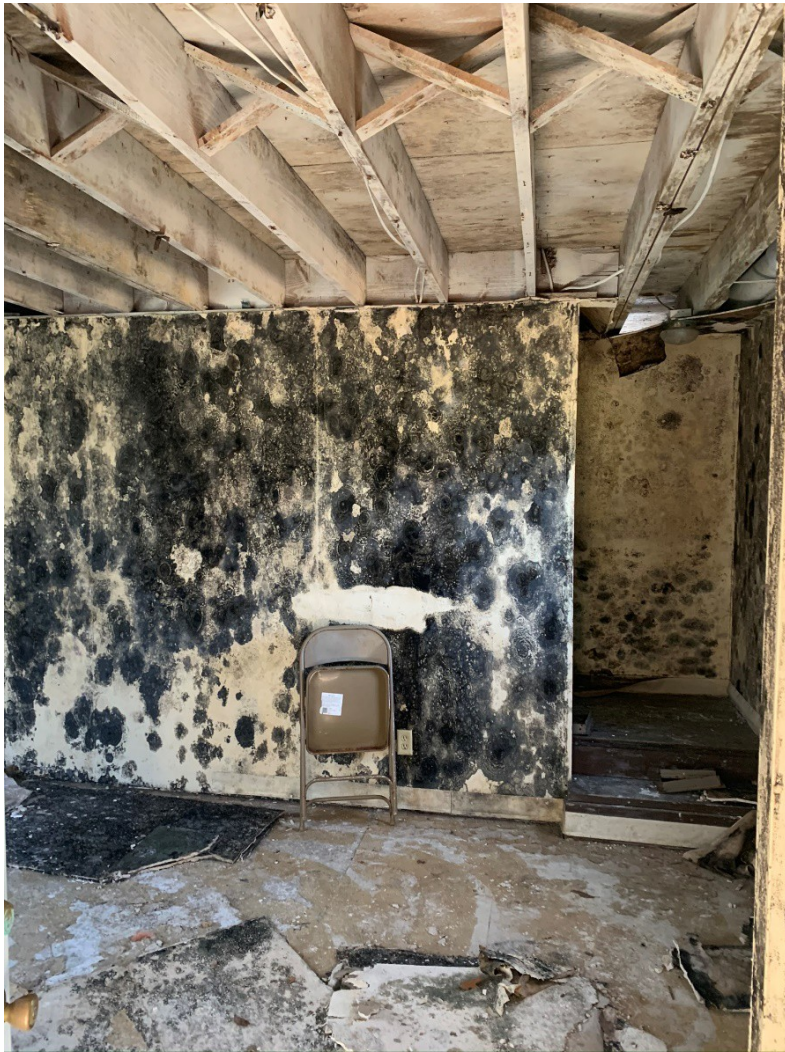
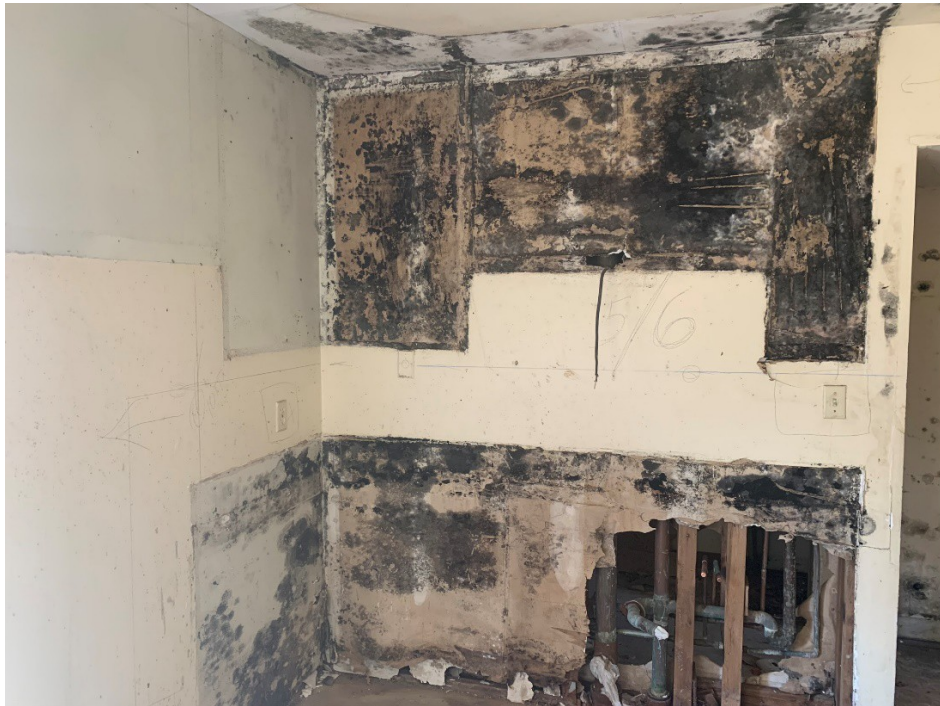
Exhibit C:
Prior Mold Issues

Mold Remediation: As referenced above, the conditions of the existing cast iron sewer lines and deteriorated copper piping manifested in water leaks and subsequent significant presence of moisture. This, coupled with a high vacancy issues, resulted in these issues left ignored and caused serious mold issues as shown in Exhibit C below. The extent of these issues preceding closing was not made apparent. Furthermore, due to positive asbestos testing in the drywall containing a lot of the mold, removal and remediation become a larger cost challenge.

With the additional complication of issues discussed above, the drywall containing mold had to be removed and replaced. The additional replacement of drywall was found to also contain asbestos, and subsequently was required to be remediated.
