801 Perry

Peoria, IL

Renovation Report

Prepared By:
Dewberry Architects Inc.
401 SW Water Street, Suite 701
Peoria, IL
Report Dated: February 2, 2015

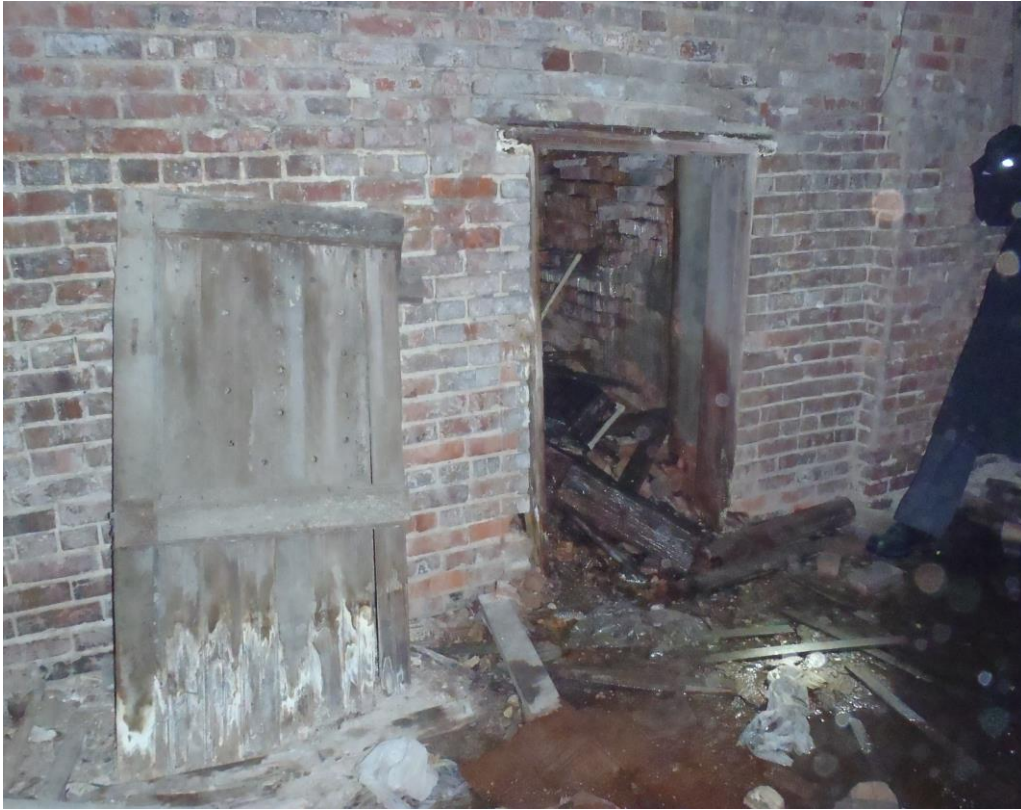
Water in basement (Infiltrating from near damaged exterior wall)

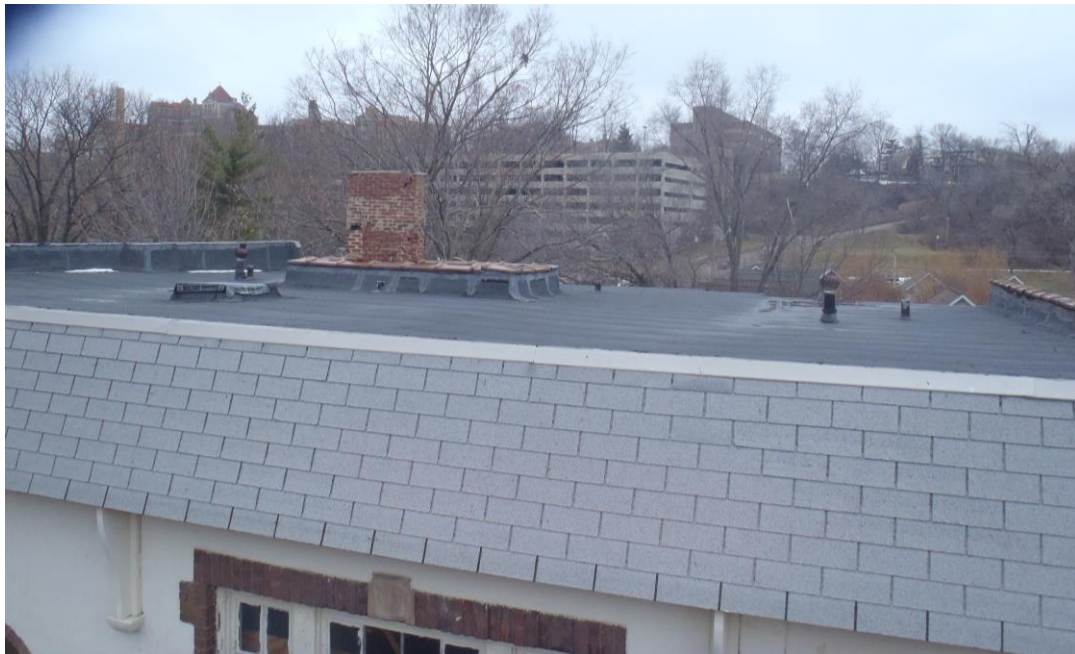
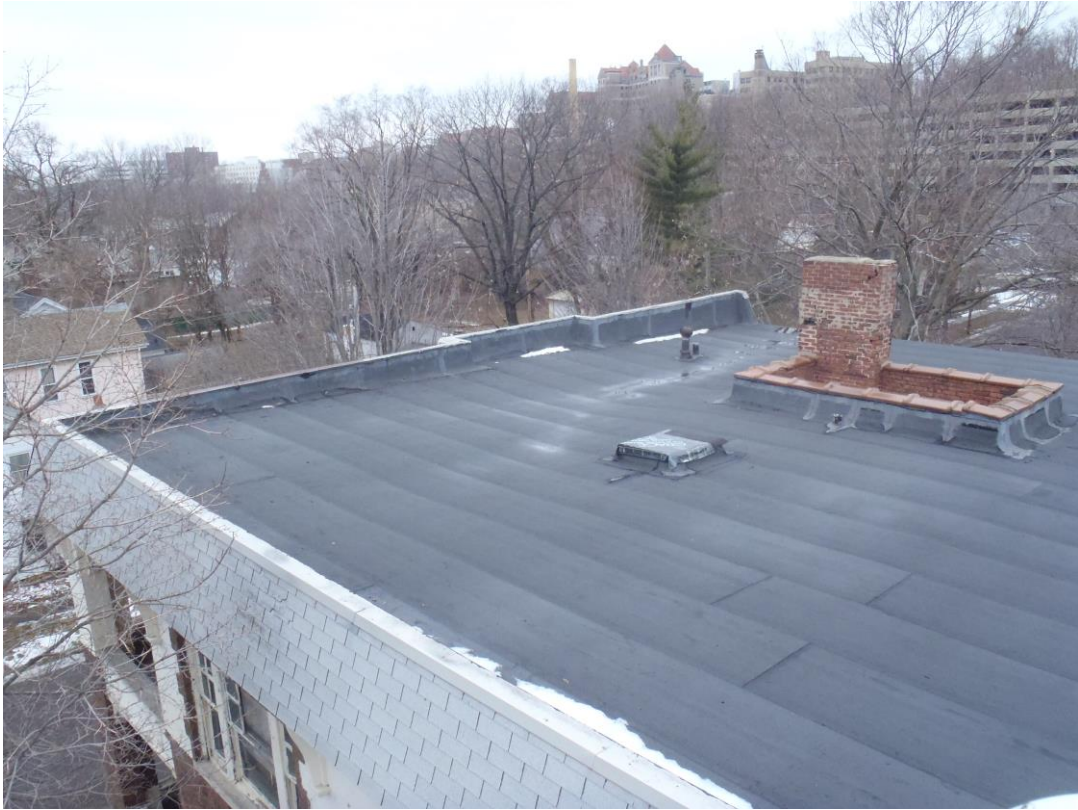
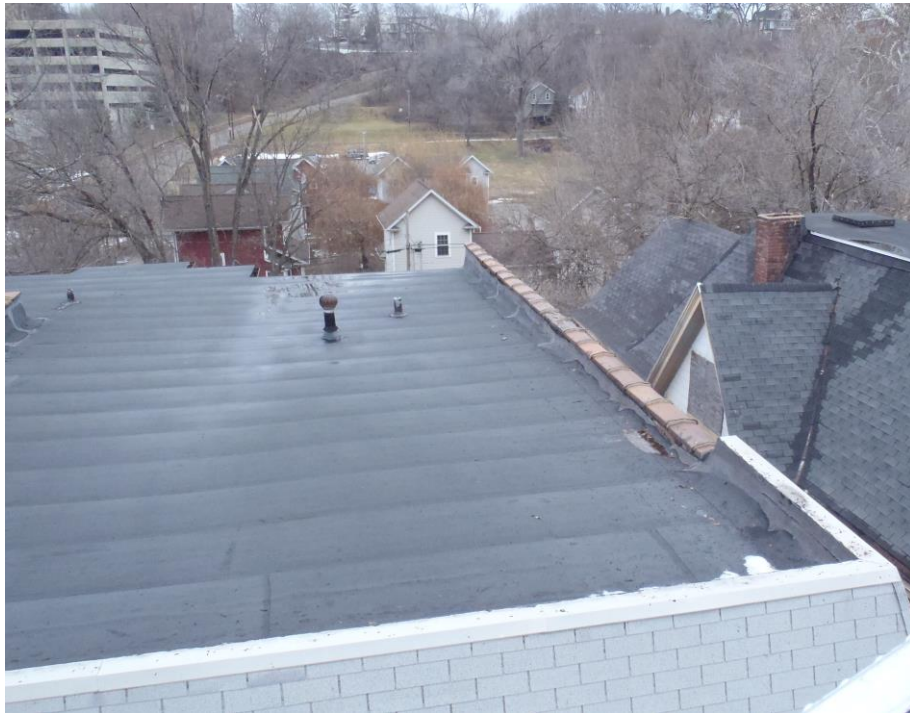
The roof appears to have been reroofed in the recent past. It appears to drain water to the rear of the building at quarter point low spots. The roof hatch has been boarded up and roofed over. The northeast parapet needs some repair and flashing work to prevent potential water infiltration.

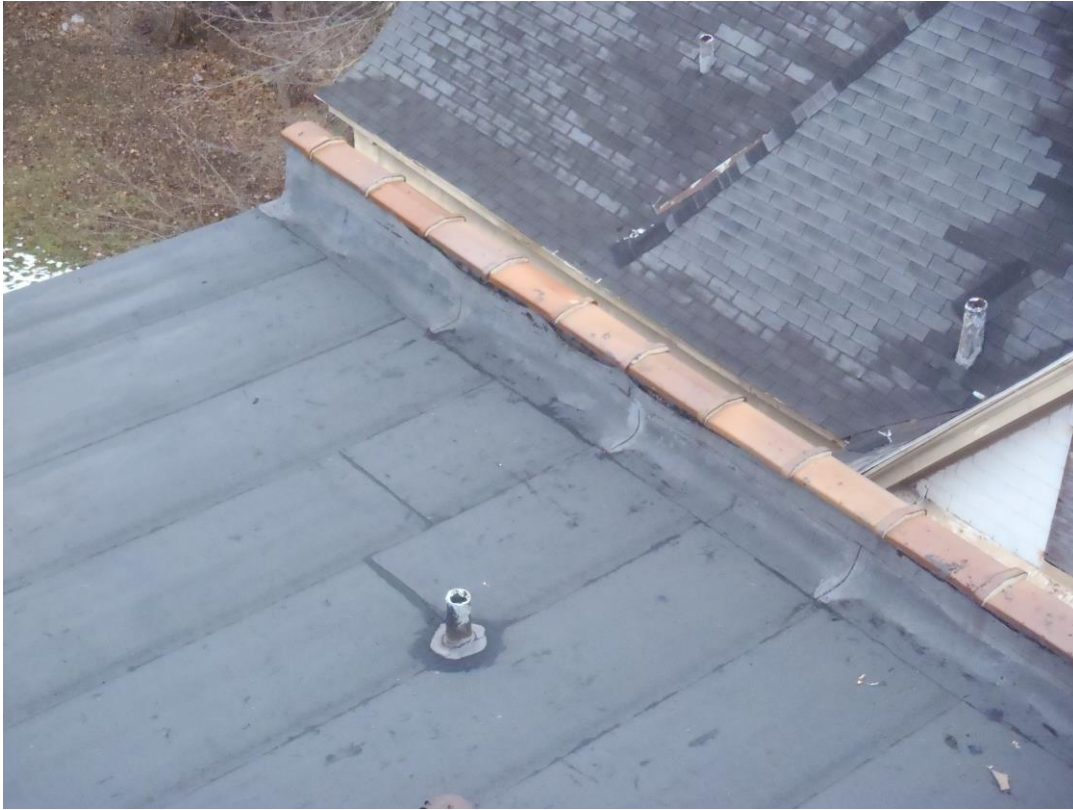
Parapet/flashing repair

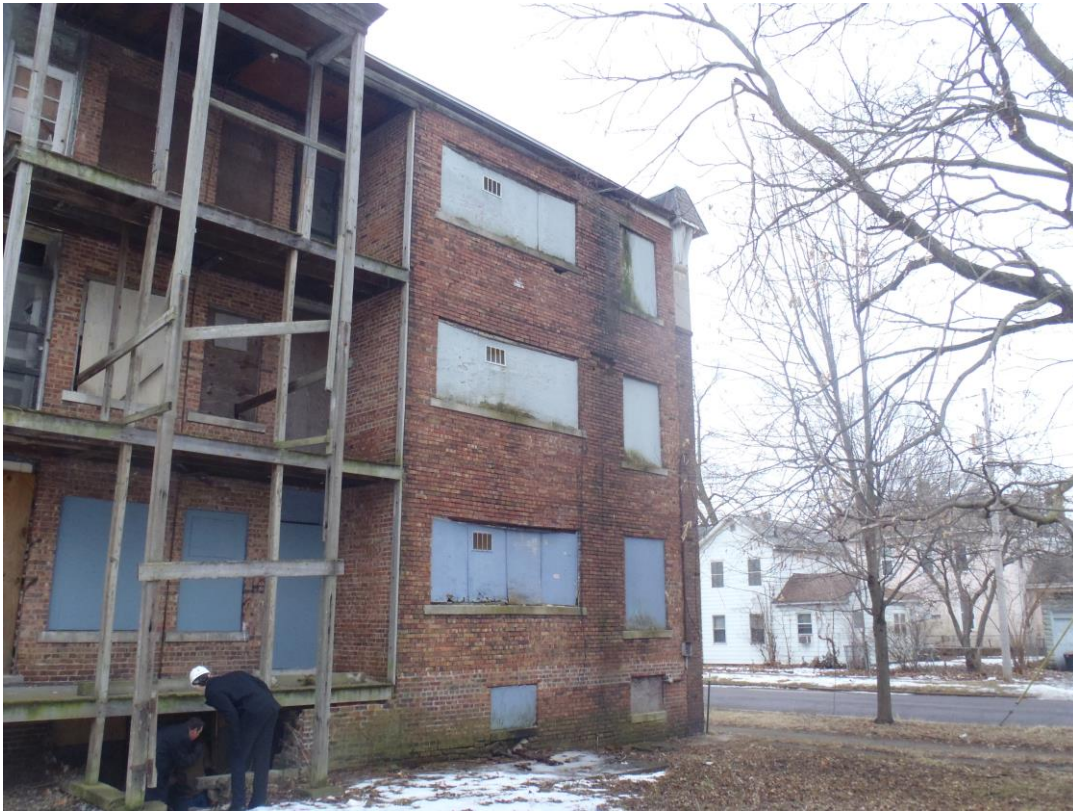
The west half of the back exterior wall has suffered severe water damage. Masonry is falling from this area and the upper portion of the wall is starting to bow. The basement wall in this location also show signs of water damage. The remainder of the exterior masonry walls need spot repairs and tuck-pointing. The remainder of the basement walls appeared to be in reasonable condition.

The back exterior stairway no longer has steps and is in need of repair.

Back wall showing water damaged masonry all the way up between the windows. Also, note missing stairs

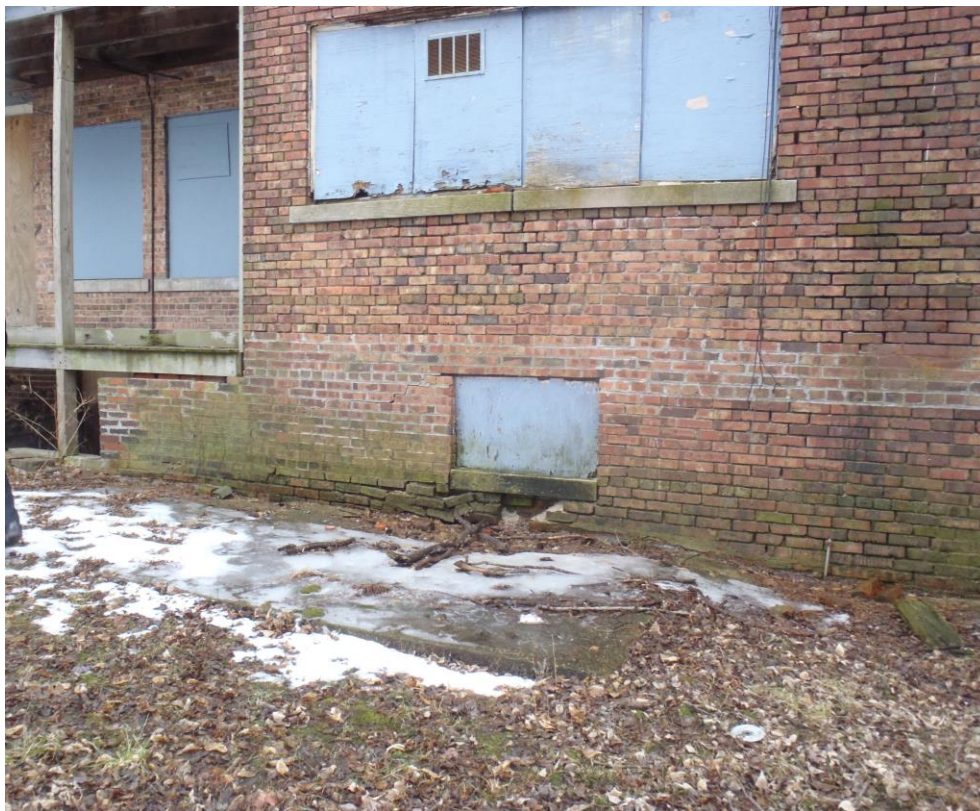
Water damaged masonry (missing brick and mortar)

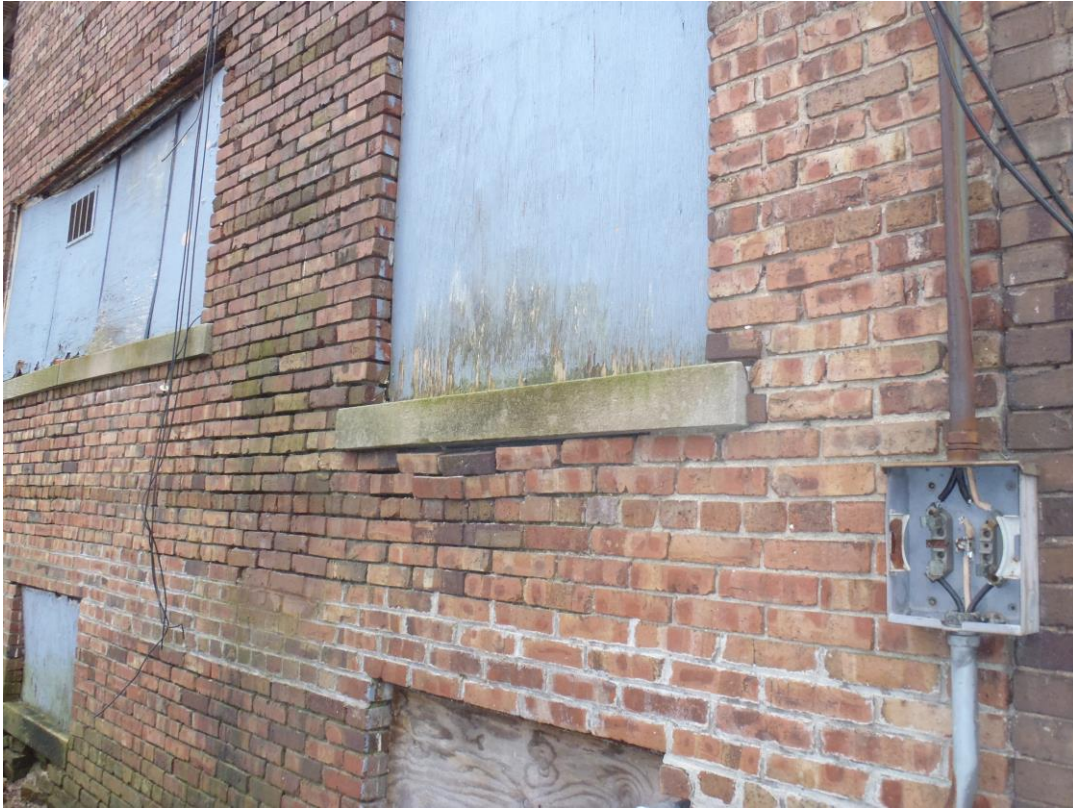
Falling masonry and missing mortar showing extensive need for repair and tuckpointing

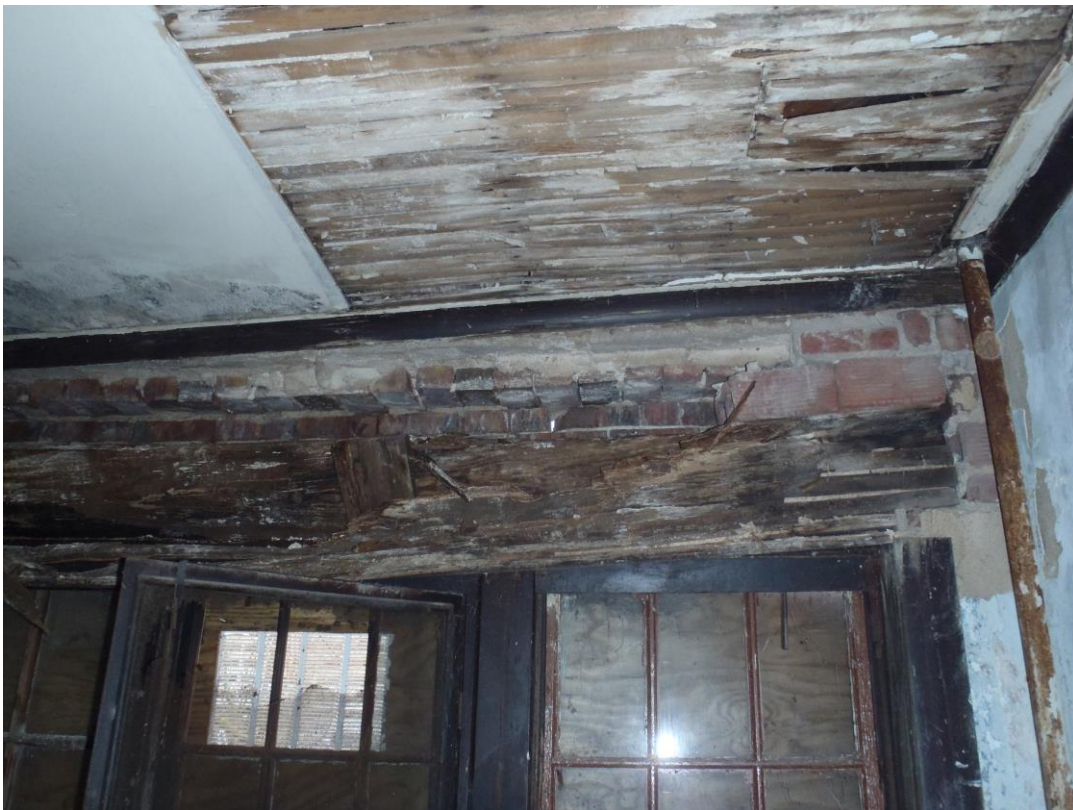
Interior view of exterior wall showing falling masonry

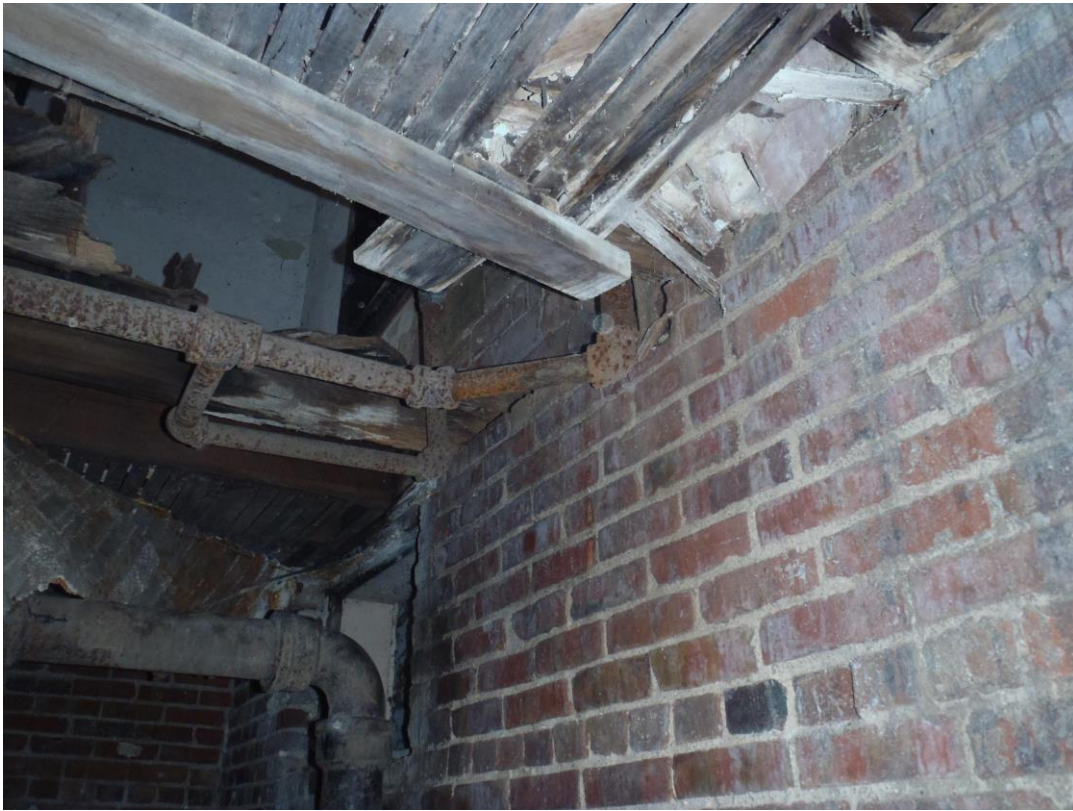
Interior view of exterior wall with falling masonry needing replacement

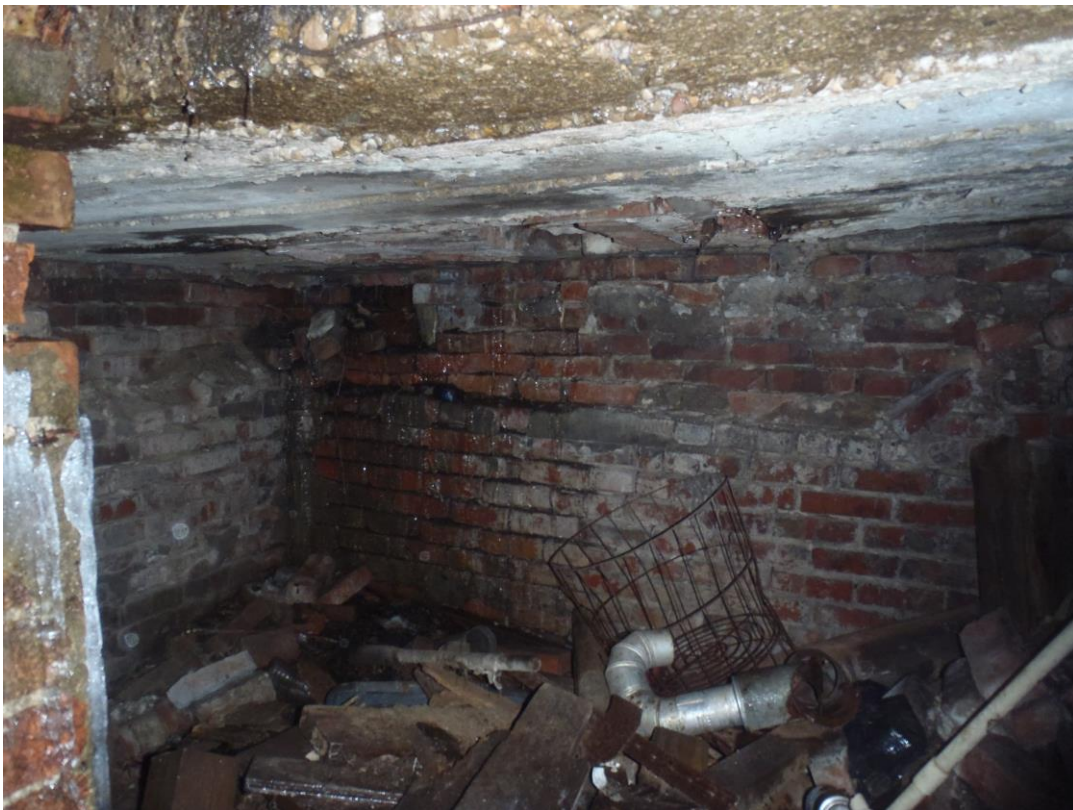
Water damaged masonry in basement is in need of rebuilding and tuckpointing

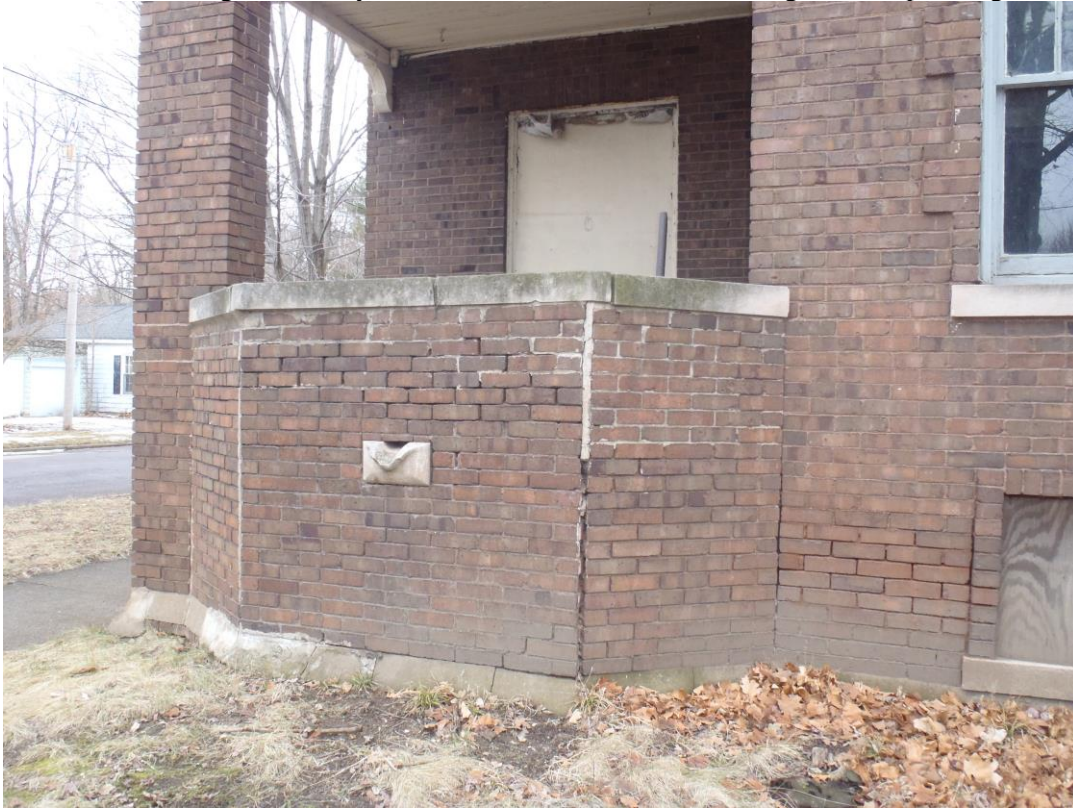
Exterior balcony needs masonry repair and tuckpointing

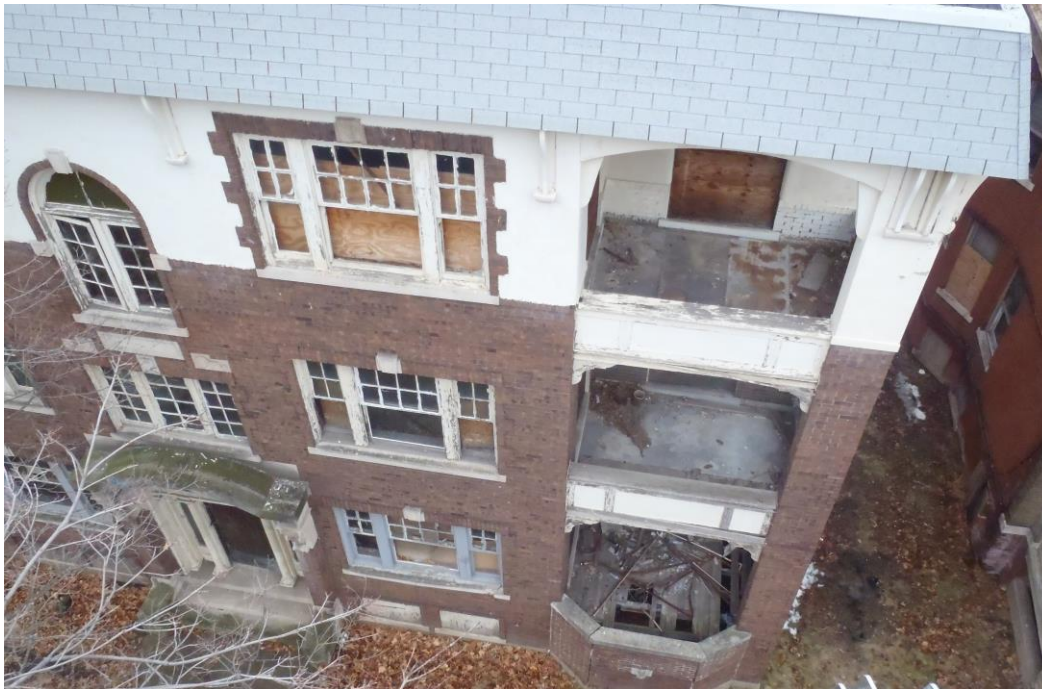
Exterior balconies and windows will require various levels of repair, including framing replacement, window frame and sash repair, glass replacement, and painting.

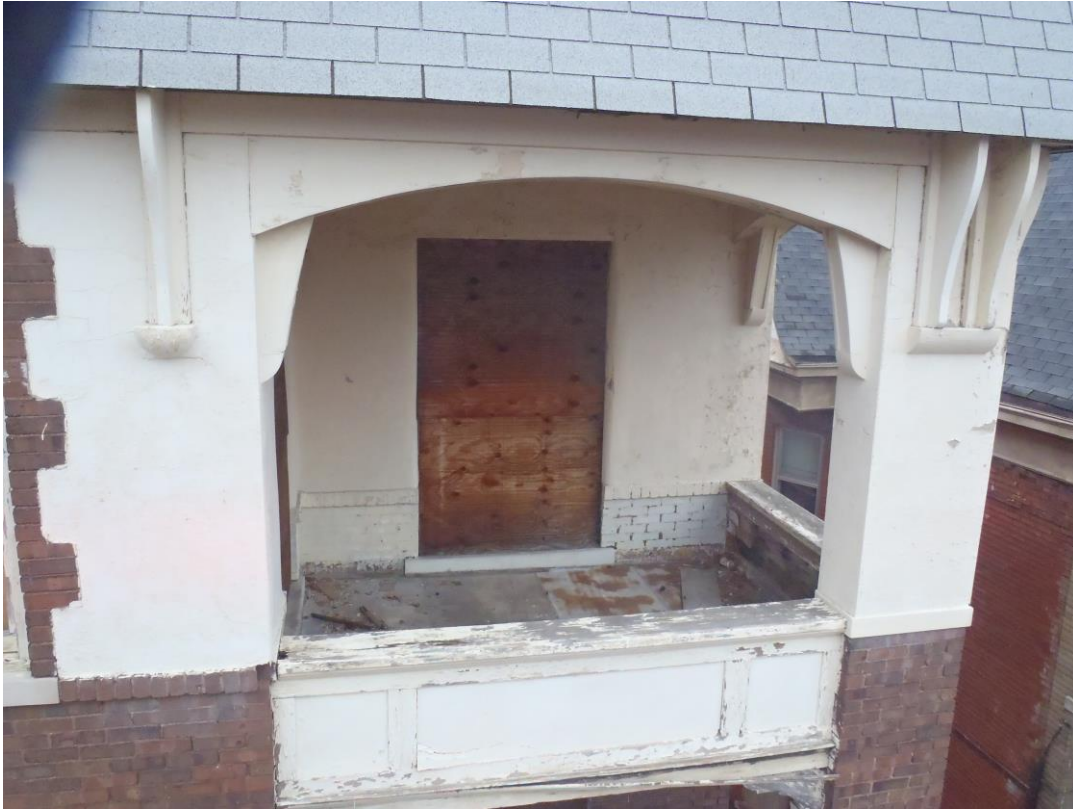
Exterior balcony and exterior wall showing peeling paint and damaged wood trim

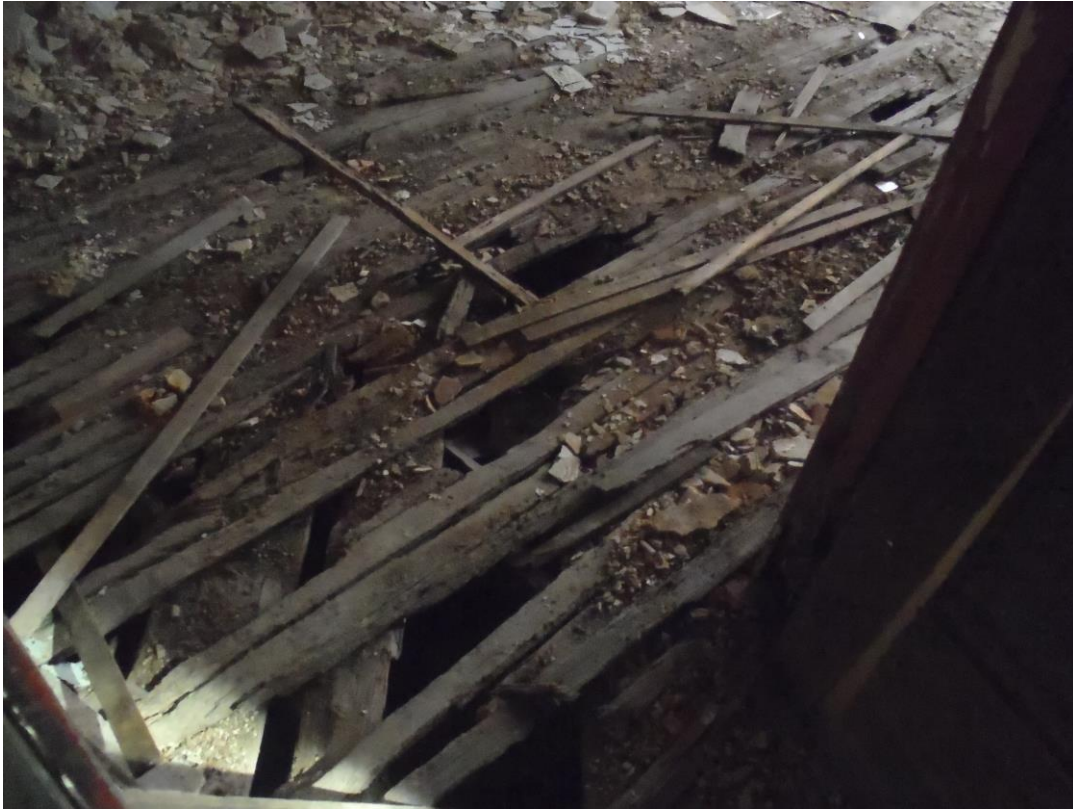
Existing deteriorated flooring needs to be removed and replaced.

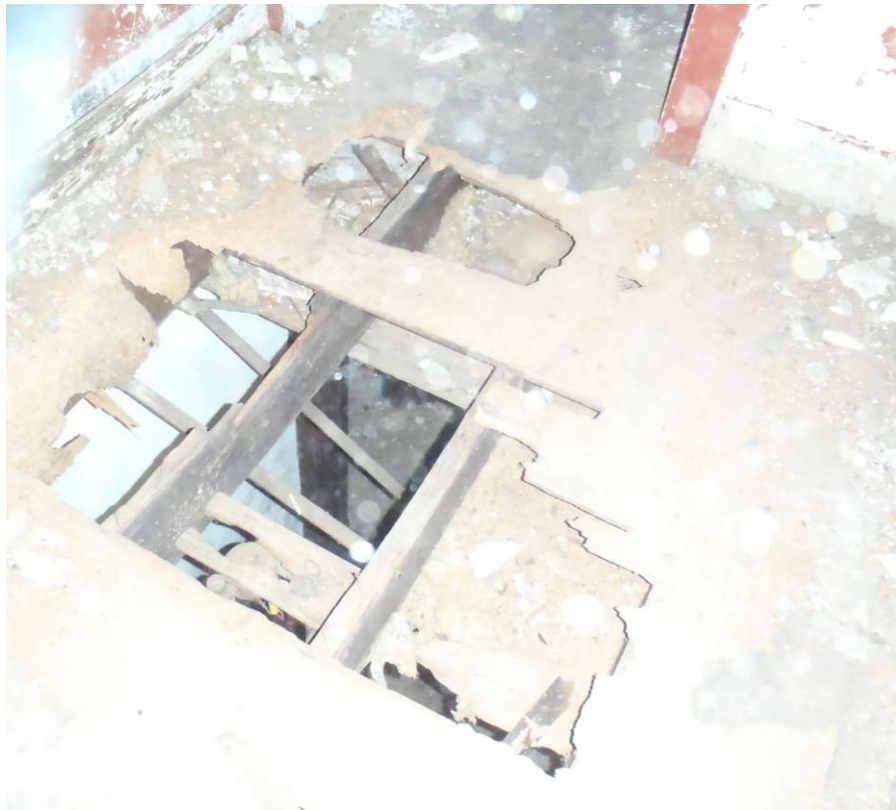
Hole in floor shows the need for repair and/or replacement of some floor framing members.

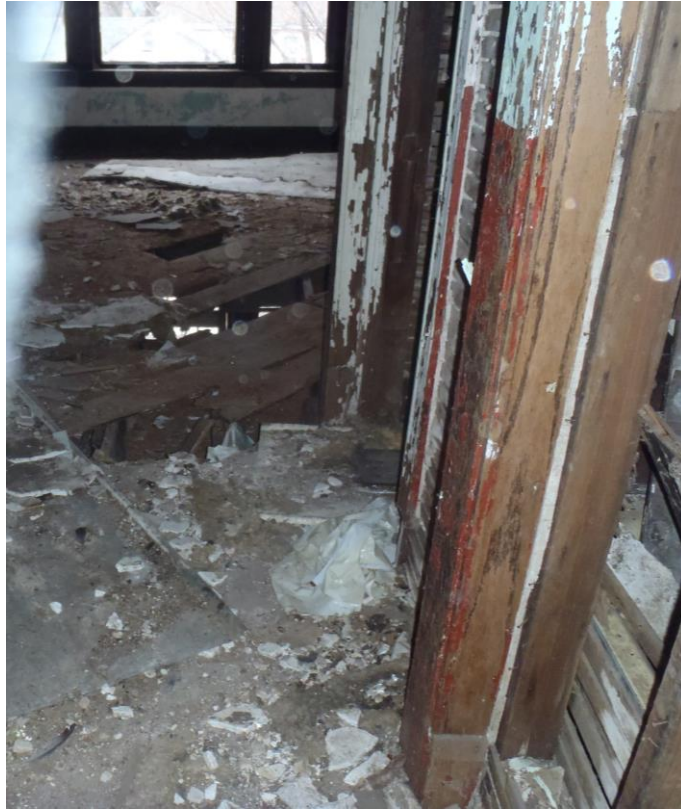
Sloping floor framing indicating the need for more extensive framing repair

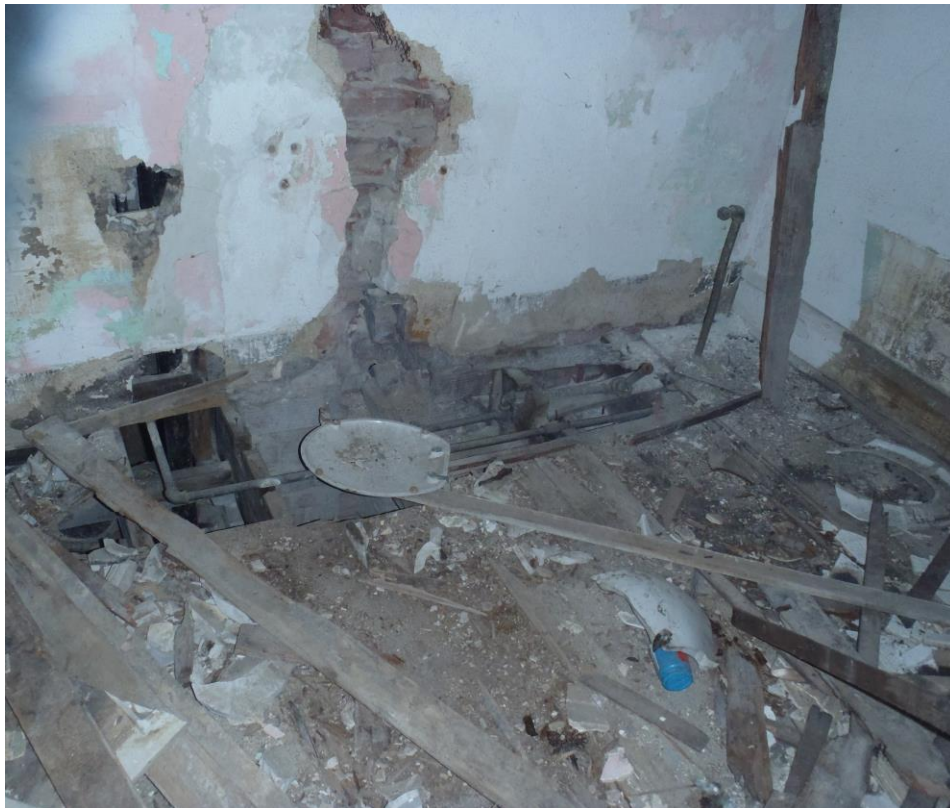
Hole in floor showing need for repair of some floor framing members

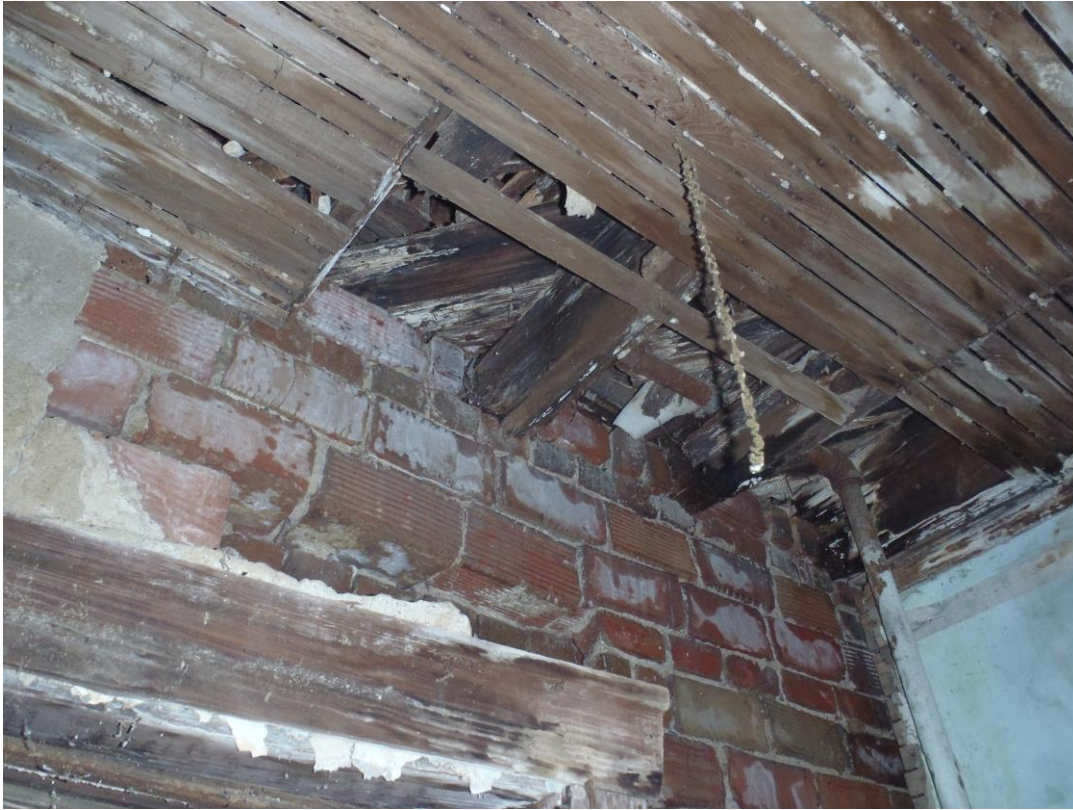
Water damaged flooring and joists indicating the need for replacement of flooring and joists

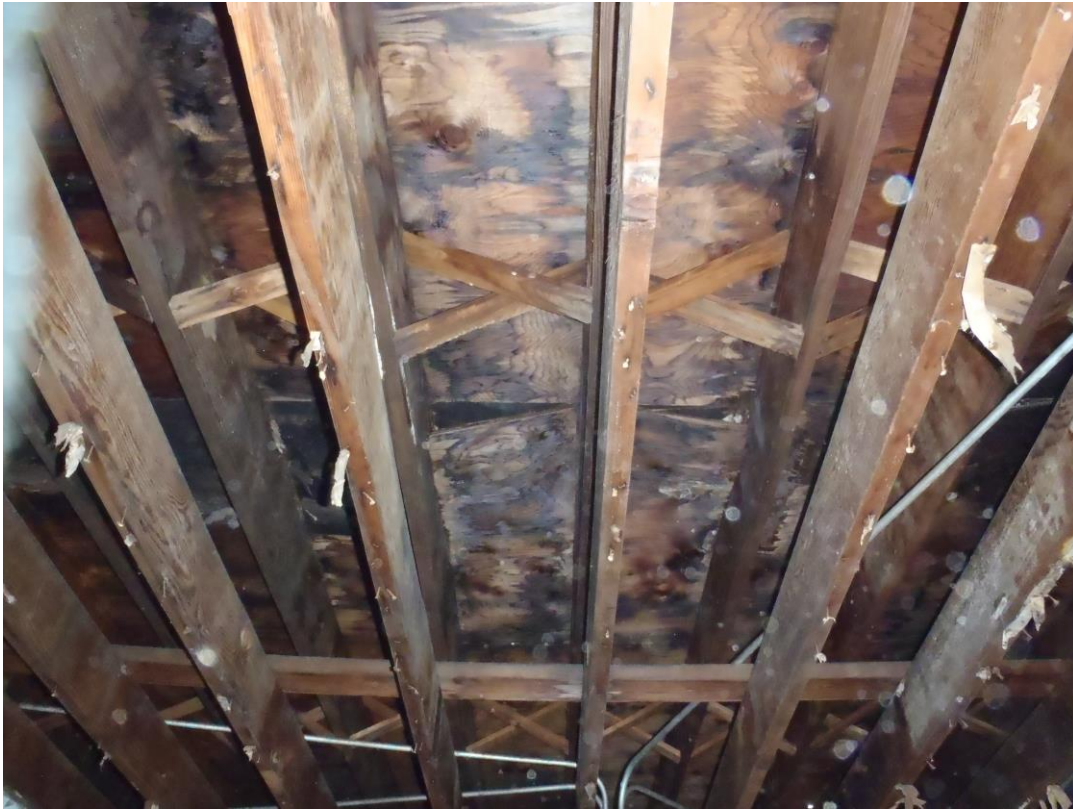
Water damaged and deteriorating roof sheathing indicating the need to replace the roof sheathing

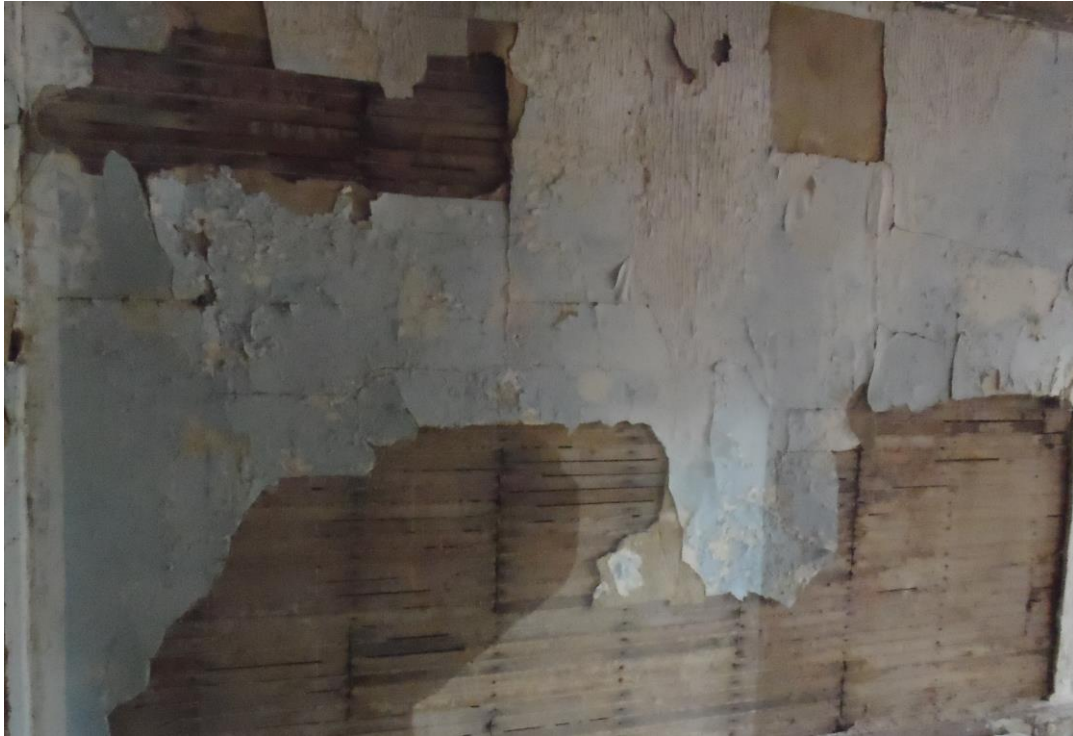
Condition of plaster walls indicating need to replace with drywall

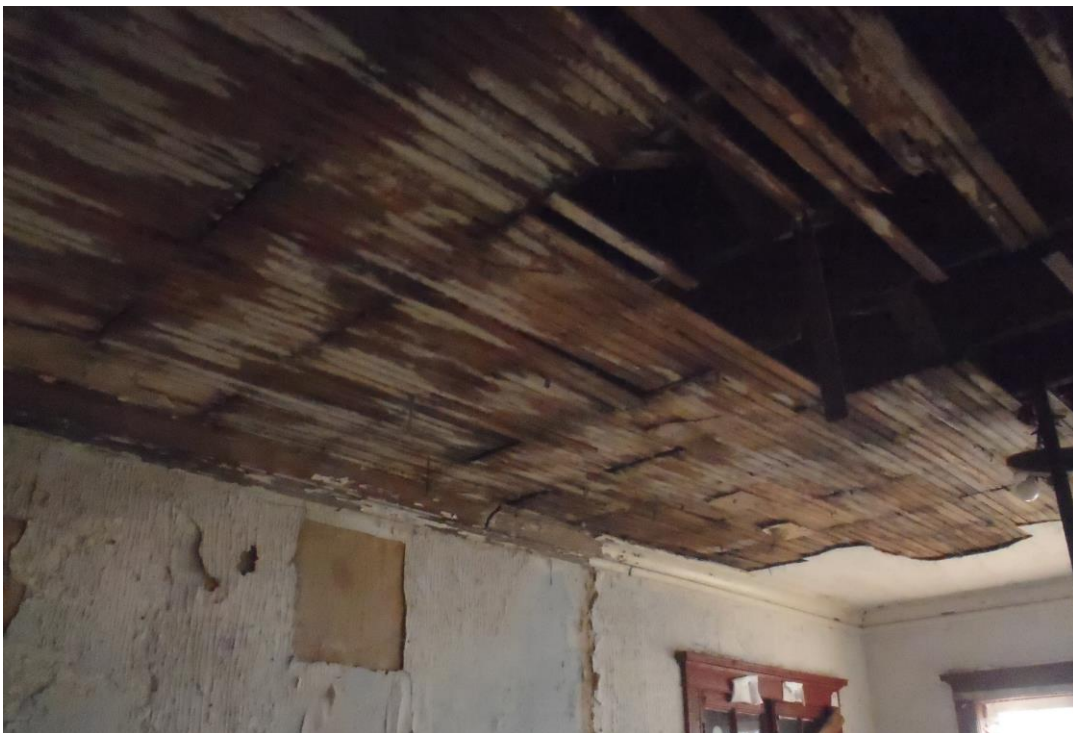
Deterioration of ceilings showing need to add gypsum board

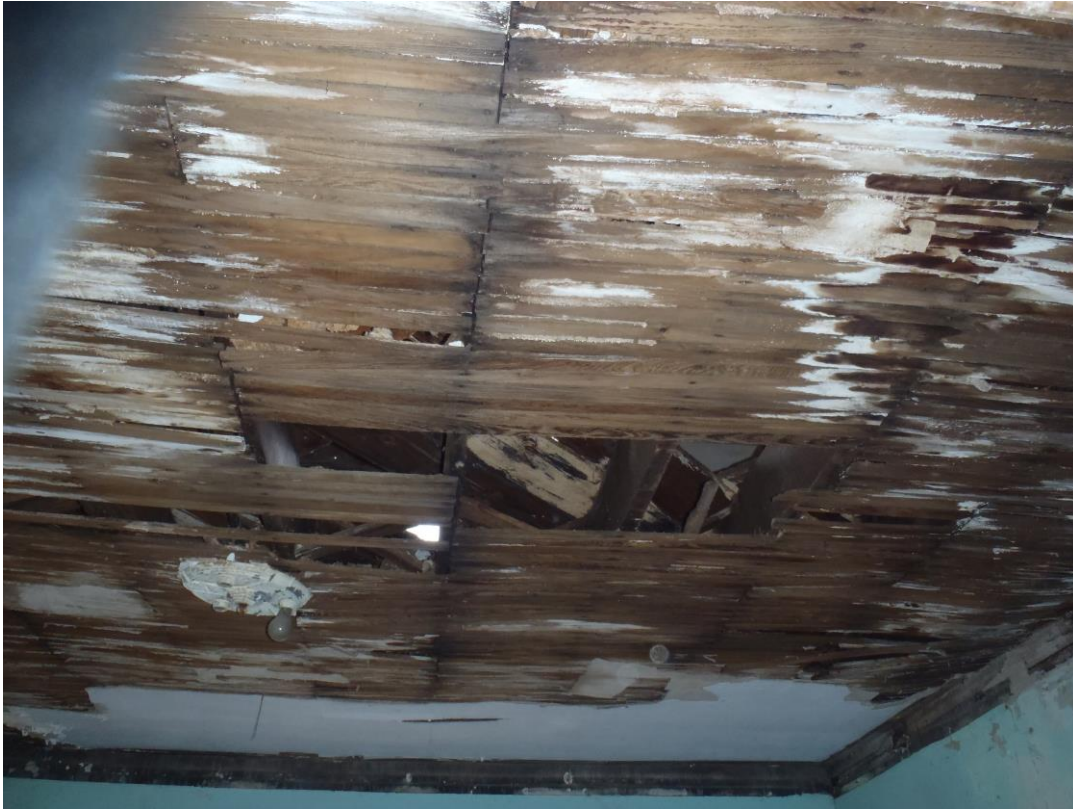
Deterioration of ceilings showing need to remove lath boards and replace with gypsum board

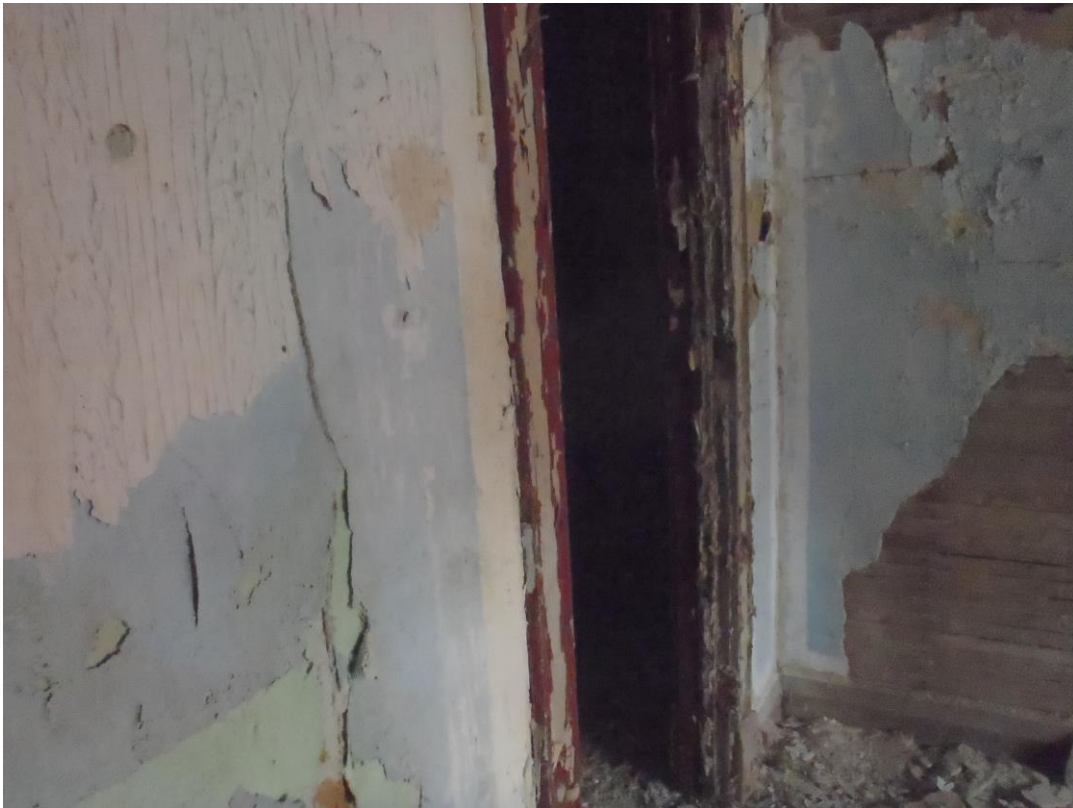
Peeling paint indicating the need to replace wood work and plaster (scaling paint on wood work is generally an indicator of lead based paints)

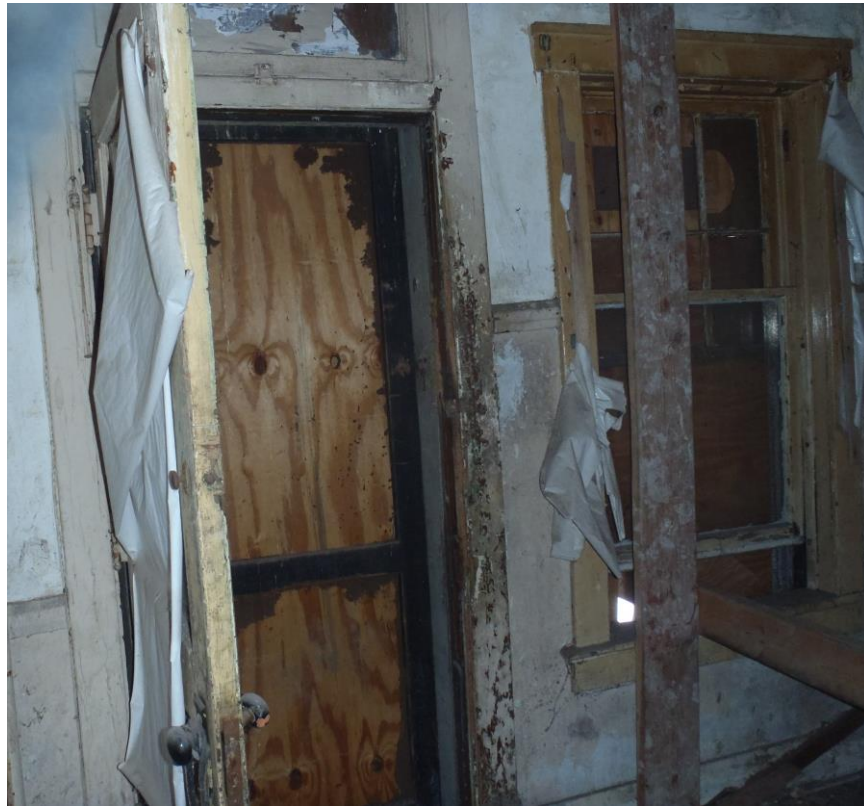
Interior view of door and window showing damaged hardware that will require replacement and peeling paint on the wood that will require replacement of the wood trim and abatement on the window sashes

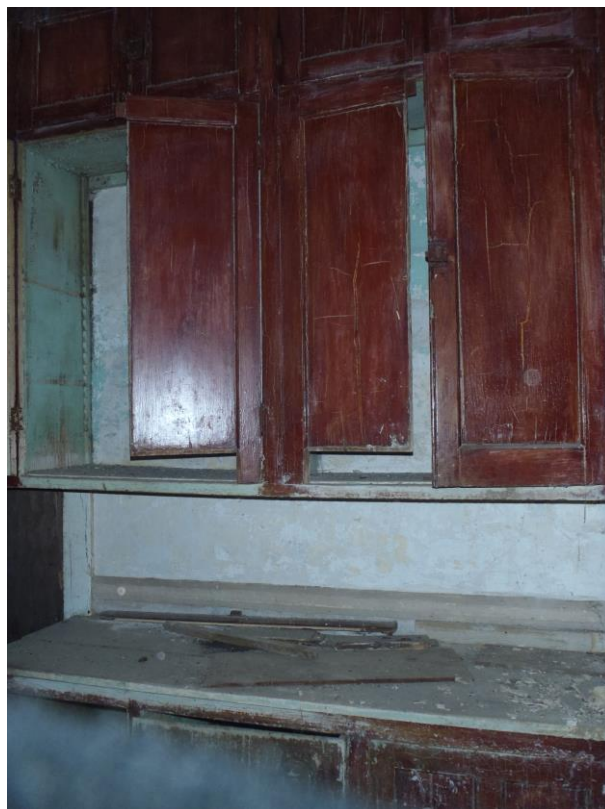
Condition of remaining kitchen cabinets indicating needed replacement

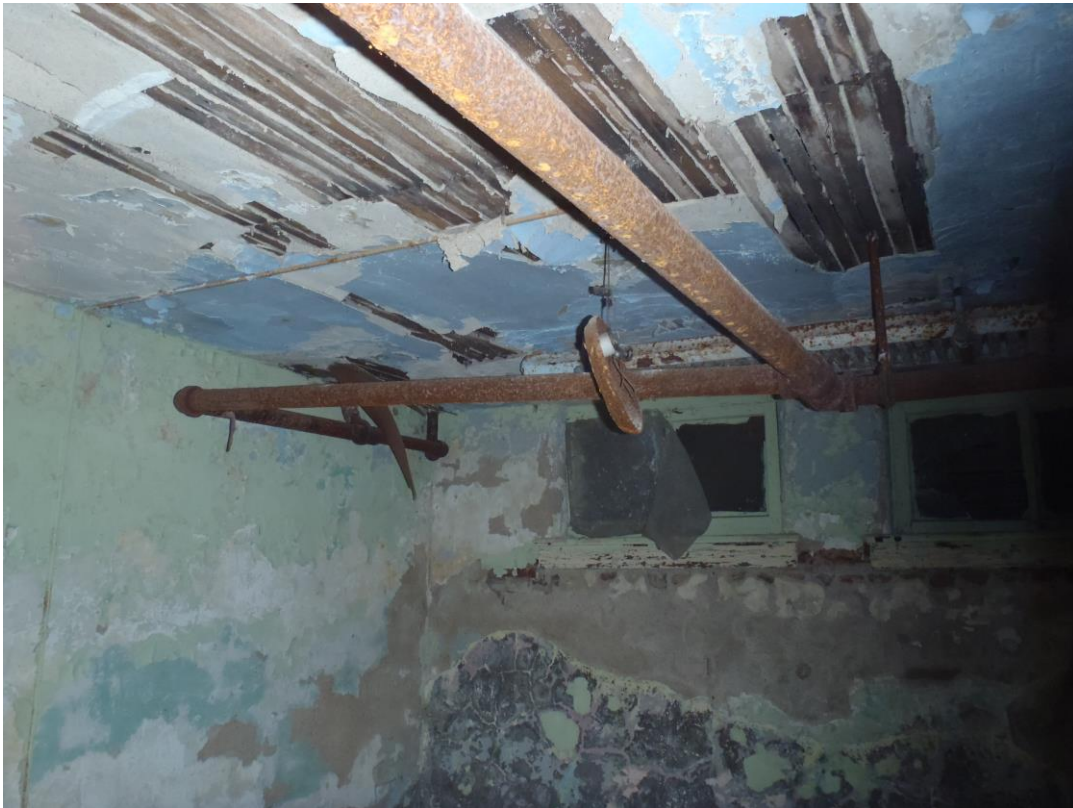
Heat piping is rusted and in need of replacement

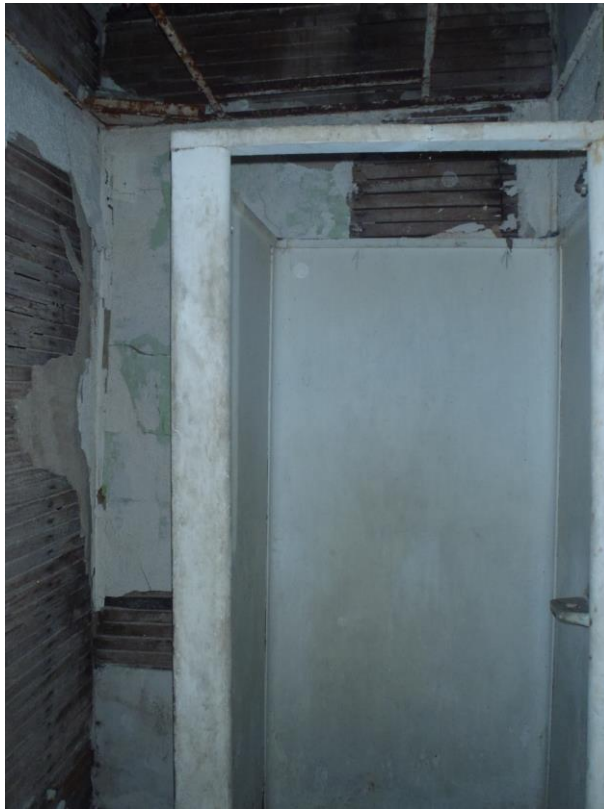
Remaining shower needing replacement
