801 Perry

Peoria, IL

Renovation Report

Prepared By:
Dewberry Architects Inc.
401 SW Water Street, Suite 701
Peoria, IL
Report Dated: February 2, 2015

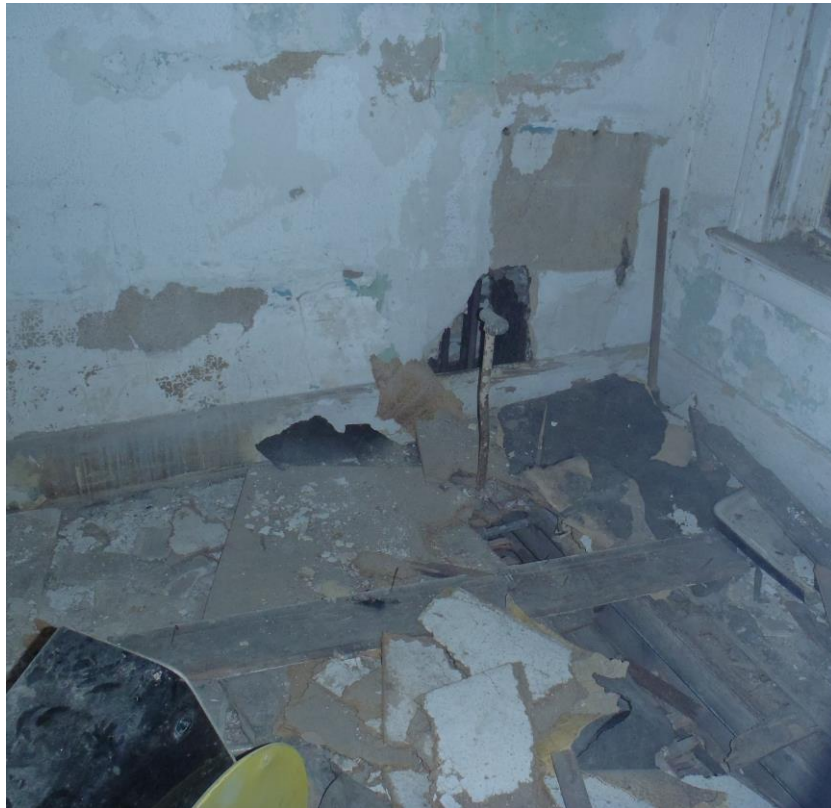
Water piping in poor condition – needs to be replaced

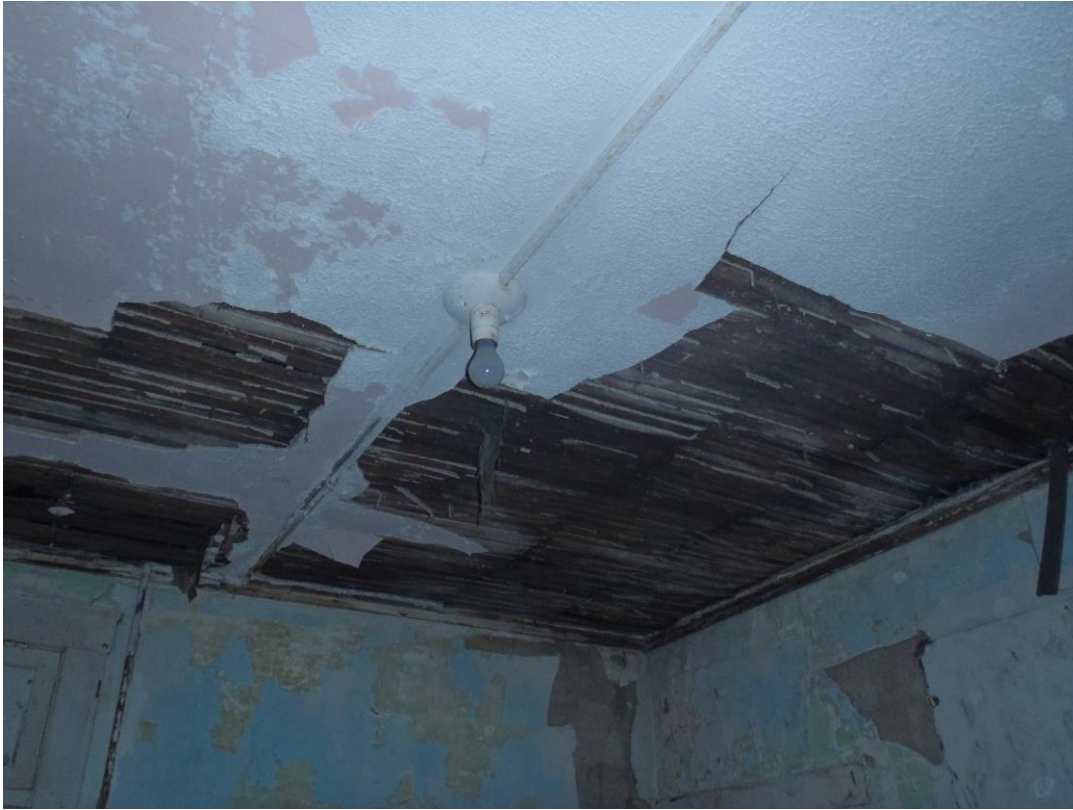
Surface mounted wire ways need to be removed and new wiring installed

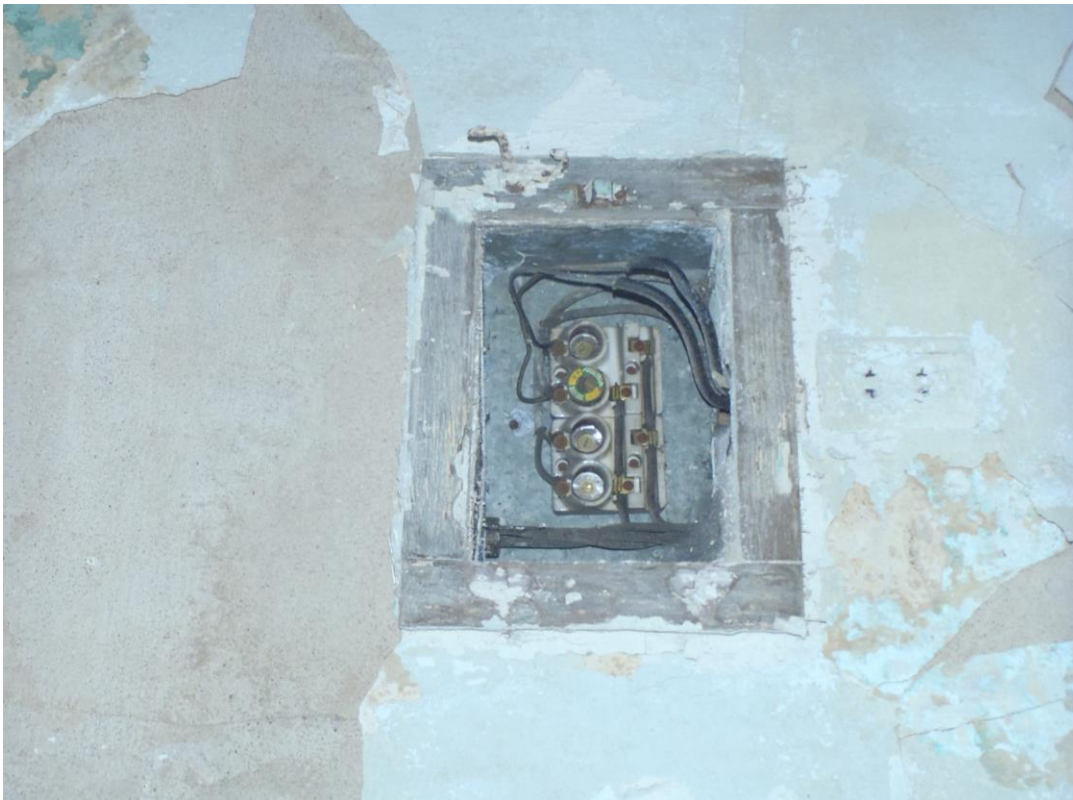
Existing unit fuse box needs to be replaced

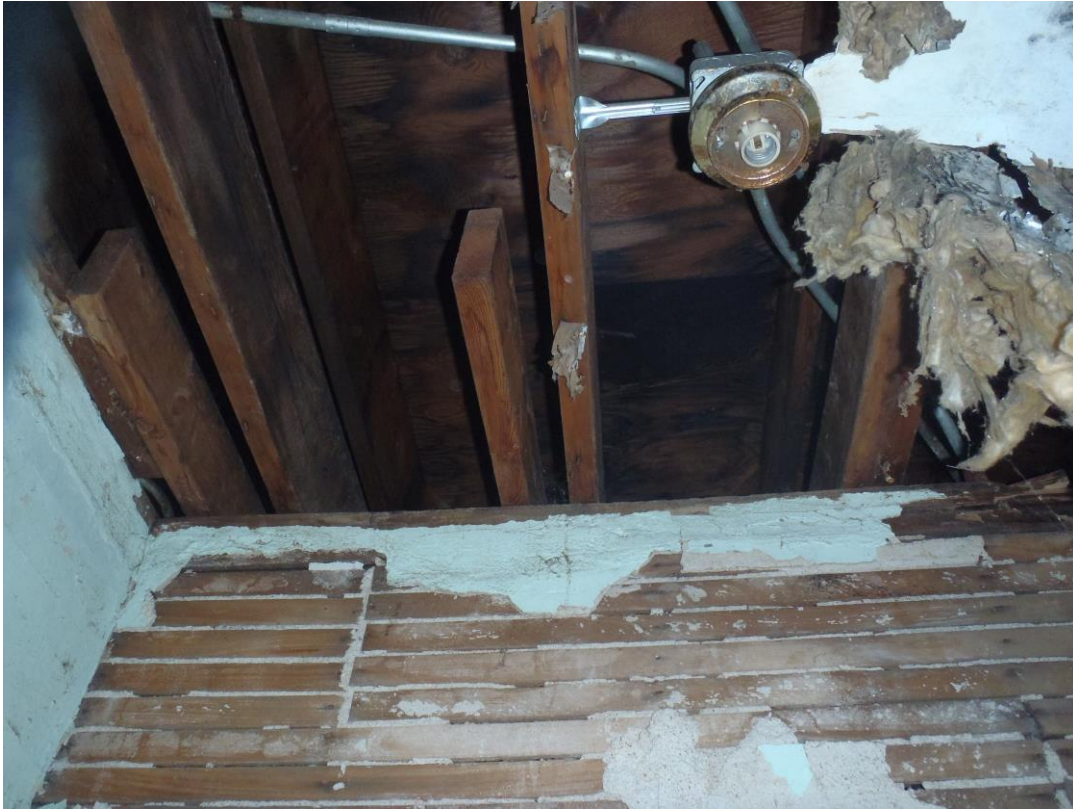
Electrical conduit potentially salvageable, but it is likely wiring will need to be replaced
