Date: October 12, 2020
To: Ross Black, City of Peoria
From: Farnsworth Group
Re: 2728 W Krause St,

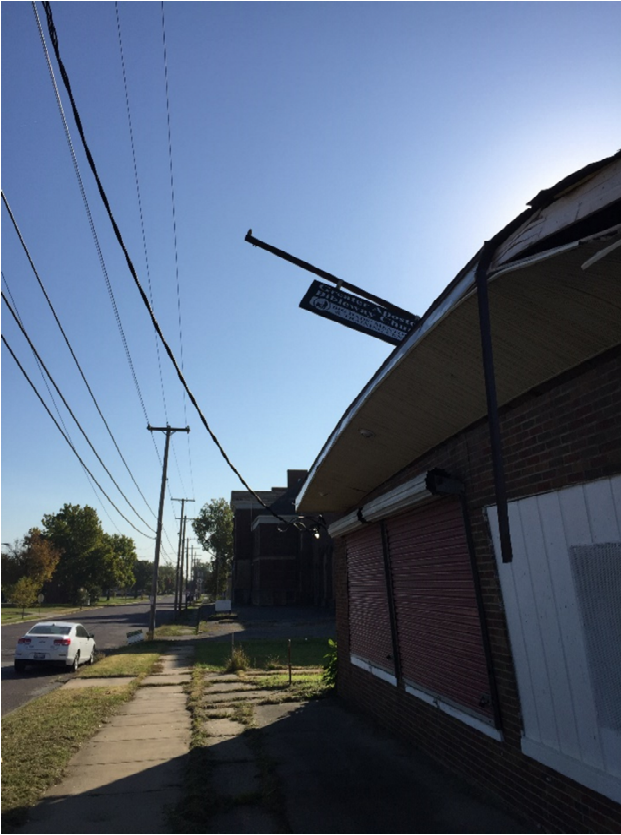
At the time of the inspection, the awning on the front of the building had distorted, rotating up by an estimated 25 to 30 degree angle. The front of the building had bowed outward by several inches at the top, just below the awning. The sidewalls at the 1st pilaster had also visibly displaced outward and the pilasters were cracked. Using the ladder to access the roof, it was found that the 1st truss had failed. This truss is located 16 feet from the front of the building.

Photo #1 Front of Building

Farnsworth Group recommends the building be condemned and the front 32 feet be demolished immediately to limit the potential for ongoing failure and collapse. The condition of the remainder of the building cannot be determined without access to the interior, but at this time such access is judged not safe.

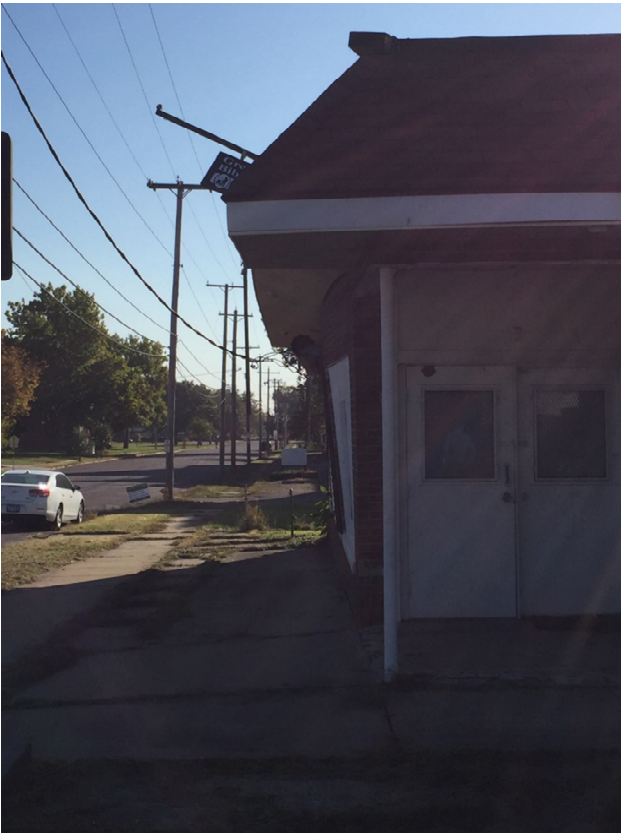
Photo #2 Front of Building

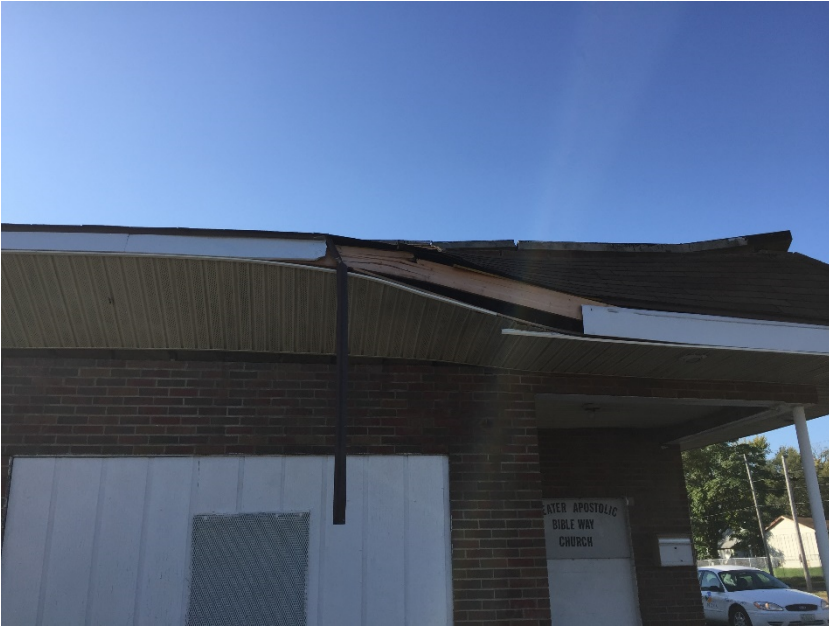
Photo #3 Front of building, awning rotation

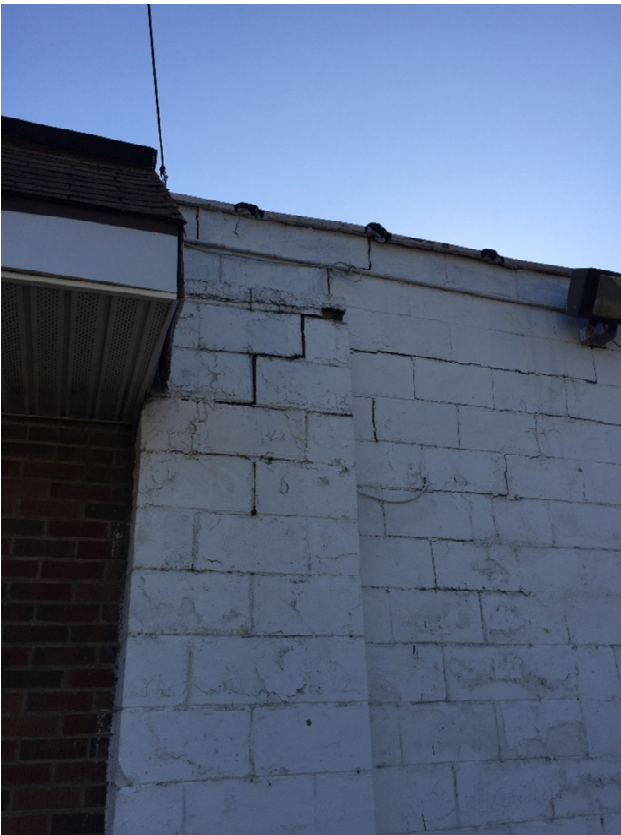
Photo #4 Cracking in 1st pilaster

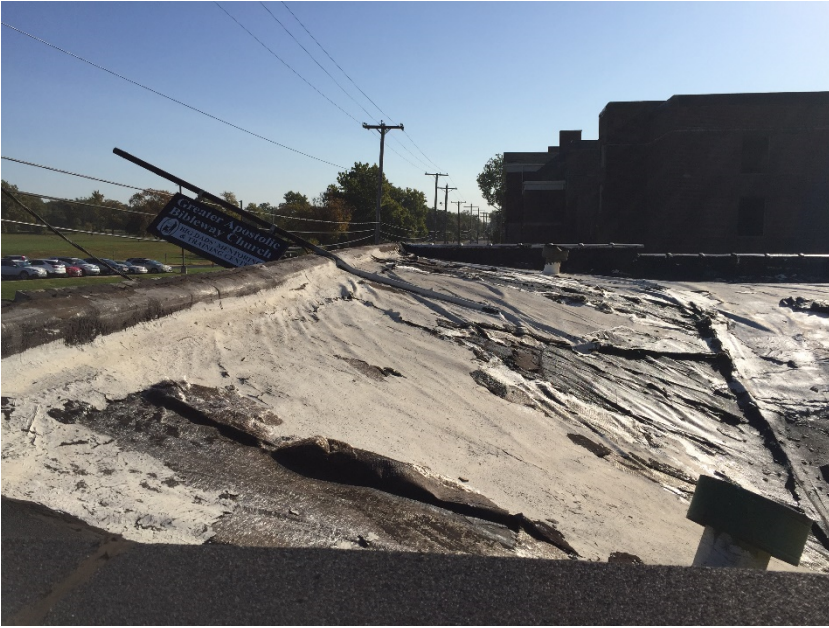
It is the opinion of Farnsworth Group that the building roof truss collapse has caused the roof purlins extending to the front of the building to rotate causing the observed distortion in the front of the building and we conclude there is a concern for the front of the building to collapse. We agree with the City's decision to barricade the sidewalk. There is also concern for progressive failure of the rest of the building should the roof failure cause an overload to the next roof truss.

Photo #6 Failed Roof

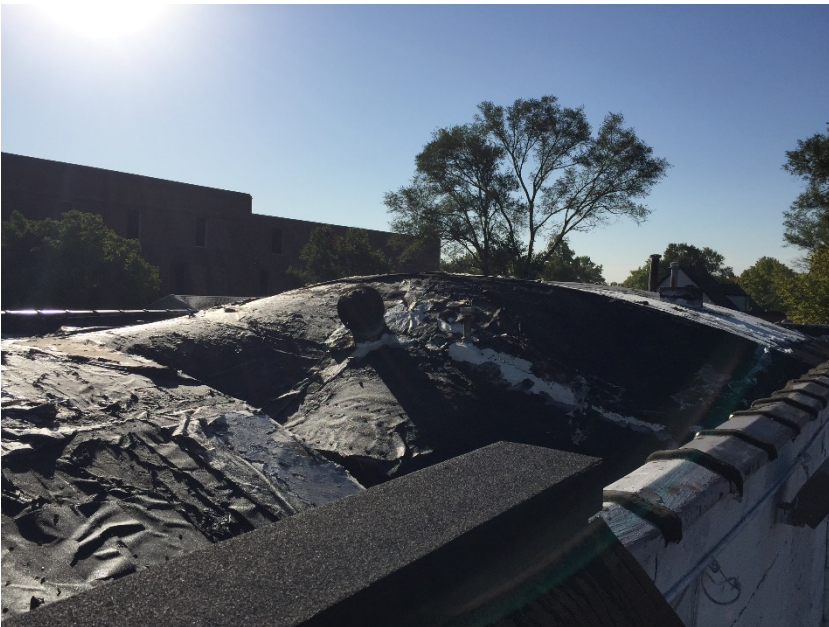
Photo #7 Failed Roof

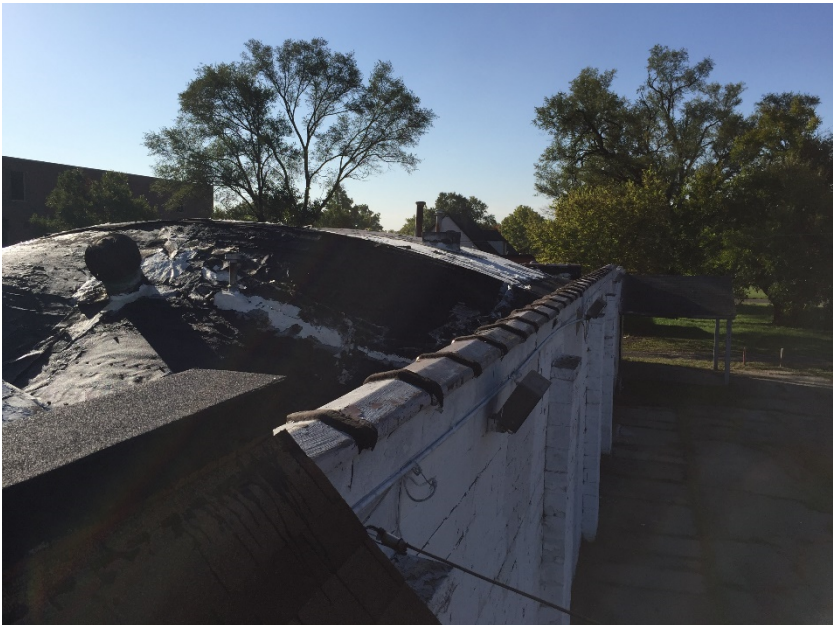
Photo #8 Failed Roof
